High-temperature failure of steel boiler tube secondary superheater in a power plant

This work investigated the failure analysis of the boiler tube secondary superheats in a power plant utility. The tube was composed of low carbon steel with 2.25Cr-1Mo addition, which was ruptured after a 26 h working test. The investigation of the tube's failure was performed through several analysis, such as microstructure, elemental analysis, and mechanical test. It was found the abrupt increase in the operating temperature as the primary factor of the material degradation of the tube. The microstructure analysis shows the existence of elongated grain with the formation of microcracks on the grain boundaries, indicating the exceeded stress applied in the material. The hoop stress in the ruptured tube was 42.47 MPa, which is higher than the allowable stress of 23.5 MPa at 605 °C. Furthermore, the equiaxed grain was observed in the unruptured tube, implying the microstructural change after exposure at high temperatures.

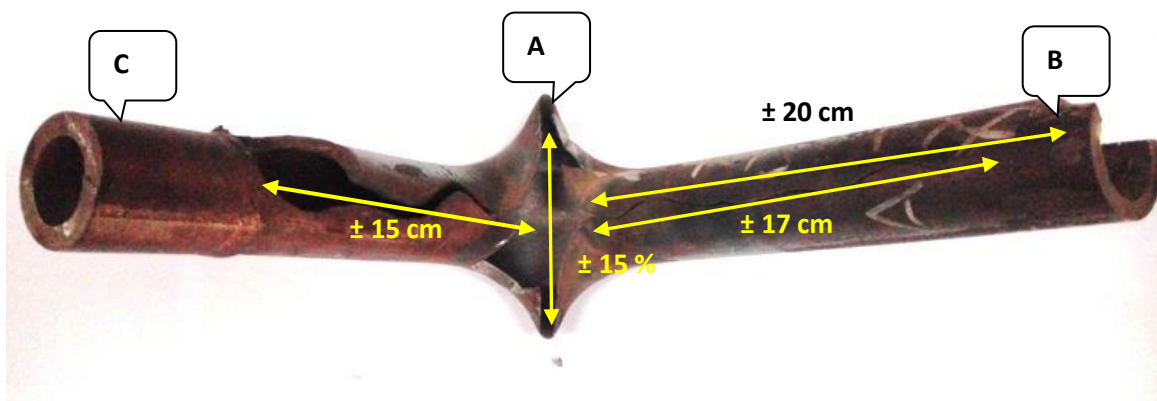
Boiler shutdown was experienced by the thermal power plant company in Suryalaya, Indonesia due to the ruptured tube, as shown in Figure 1. Therefore, this research aims to investigate the cause of ruptured tube on a boiler secondary superheater (SSH) unit and to understand the failure (open rupture) mechanisms that resulted in the termination of the operation of the boiler.

The ruptured tube used in this study was SA-213 T22, low carbon steel with the addition of 2.25Cr-1Mo (wt.%). For comparison, a new tube was also examined thoroughly as the standard. The burst boiler tube was observed and analyzed at the three different locations (points A, B, C), as shown in Figure 1. Point A was located in the wide crack of the burst area, which is known as fish mouth opening failure [15,16]. Point B was set ± 20 cm from the burst area, and 3 cm from the final crack location. Meanwhile, point C was placed in the crack-free area. The tube was cut at points A, B, and C for the microstructural and mechanical properties examinations.

Figure 1. Image of a ruptured tube, including the location of points A, B and C.

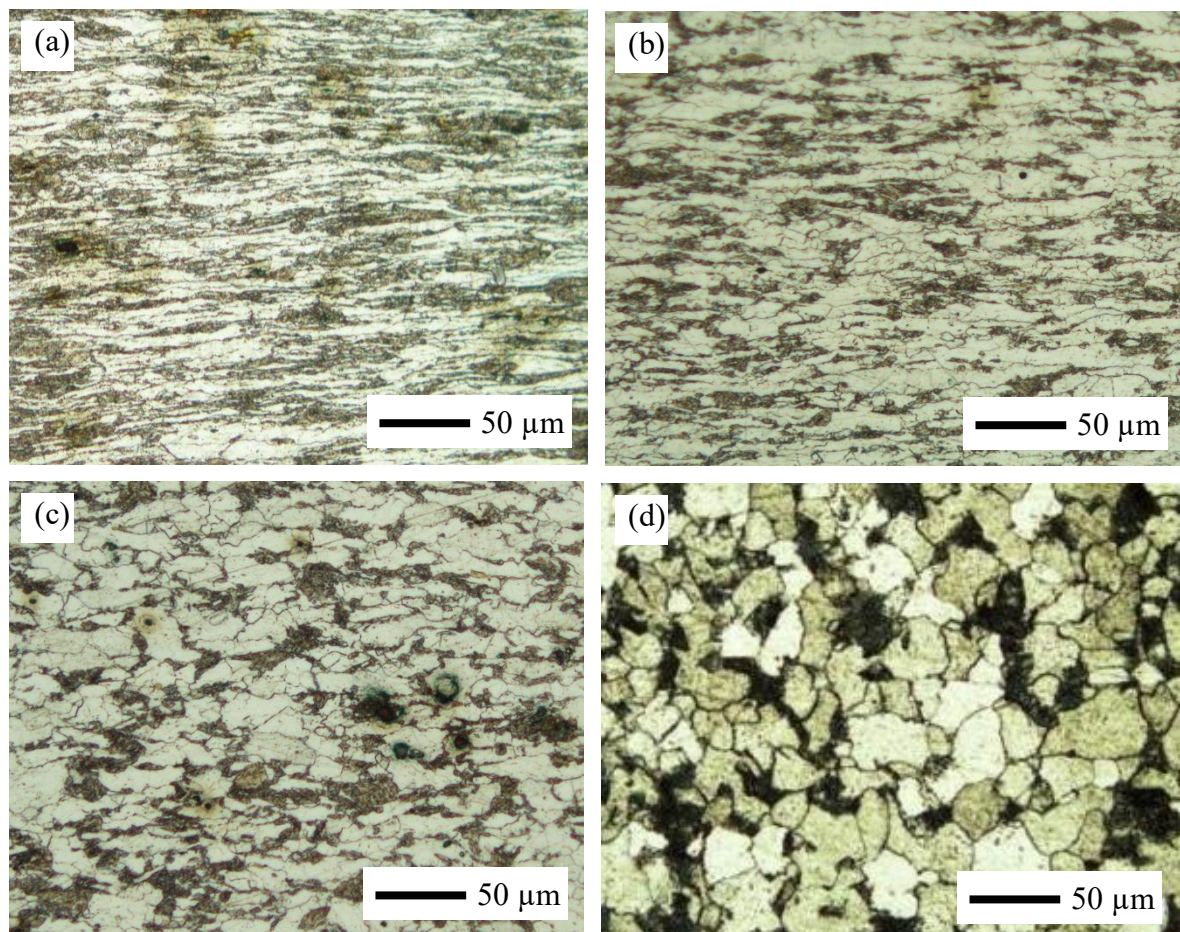
Figure 2 shows the microstructure of the ruptured specimens and the standard tubes obtained by the optical microscope. As observed in Figure 2 (a), point A exhibited a lamellar structure due to elongation of the grain. The lamellar microstructure consisted of ferrite (white/gray) and pearlite (black) phase, similar to those in the standard tube (Figure 2 (d)). However, the standard tube exhibited the equiaxed grain.

The microstructure of point B in Figure 2 (b) also displayed the lamellar grain. The grain similarity of points A (burst area) and B (near the crack area) results from the applied high stress, which consequently deformed the grains. Furthermore, the aspect ratio of the grain in point A was calculated as higher than that in point B, which indicated higher stress in point A. On the other hand, the grain shape at point C (Figure 2 (c)) is quite similar to that of the standard tube (Figure 2 (d)), suggesting lower applied stress in this point.

According to the optical microscope observation, it can be implied there is a dependency of grain shape toward the different locations, wherein the more elongated grain was

found in the crack area. The elongated grains indicated that the grain experienced severe deformation due to high stress [17-20].

The mechanical properties of all specimens are summarized in Table 2. The hardness value at point A was 213 ± 25 HB, which was higher than the standard tube (163 HB). This increase can be attributed to the microstructural change from the equiaxed to the elongated grain, as shown in Figure 2. This result is in agreement with Casagrande et al. that the hardness value was changed due to microstructural alteration [21]. Moreover, the yield and tensile strength of the ruptured tube were found to be higher than that of the standard tube, as shown in Table 2, which was consistent with the hardness values.

Figure 2. Optical microscope images of the ruptured tube at points (a) A, (b) B, (c) C and (d) the standard tube.

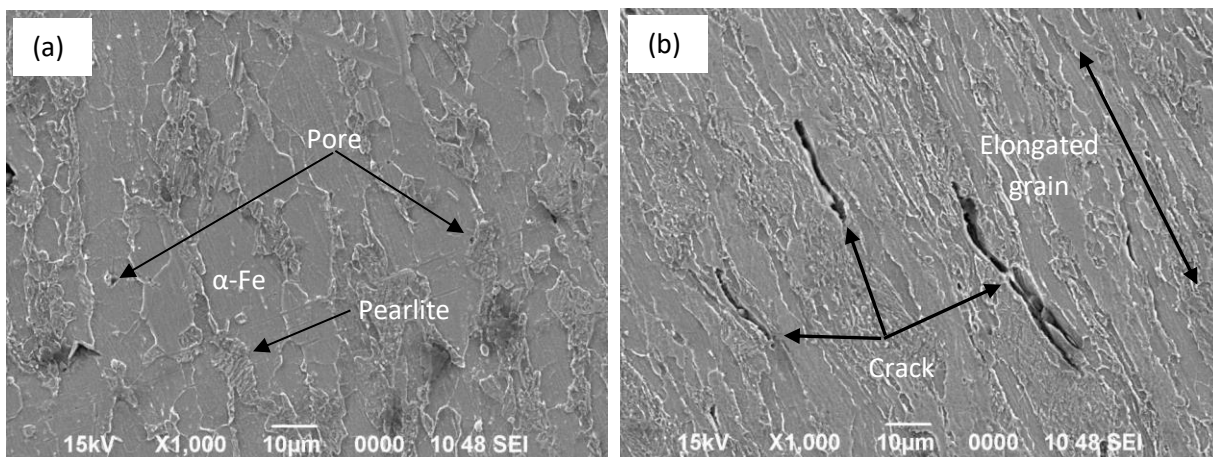
Figure 3 presents the SEM images of the standard and ruptured tubes. The microstructure of the standard tube exhibited equiaxed grain consisting of the ferrite phase (α -Fe) and pearlite (α -Fe + Fe₃C), as shown in Figure 3 (a). This result is in agreement with Chandra et al., which found an elongated grain in the ruptured tube [22]. In addition, several pores were observed in the standard tube. In contrast, elongated grains with a high aspect ratio were formed in the ruptured tube, composed of ferrite and pearlite (Figure 3 (b)). This result is consistent with the optical microscope image in Figure 2(a). Interestingly, several cracks were found in the ruptured tube, as shown in Figure 3(b). The crack was possibly originated from the pores, which were elongated and then propagated because of high stress. EDS analysis of Figures 3(a) and 3(b) is shown in Table 3. The results show that the ruptured tube contained higher carbon content than the standard tube. The hardness increment of the ruptured tube can also occur due to higher carbon content in cementite. Thus, the ruptured specimen's hardness and strength increase due to the formation of the elongated grain and the cementite phase. Another interesting from EDS analysis was O detection in the ruptured tube, as shown in Table 3. It indicates that the tube experiences

oxidation, which is characterized by the presence of O. Indeed, there is a weight increase because of the formation of a new oxide phase during oxidation, as reported by Aryanto et al. [23,24].

In this case, the degradation of material causing the tube breakage after 26 working hours occurred due to overheating and overpressure at a specific location. The overheating and excessive pressure took place in the operation due to the clogging of the fluid stream within the tube, leading to the anomaly in the fluid circulation.

Figure 3. SEM images of (a) the standard tube and (b) the ruptured tube.

The early degradation during the boiler start-up can be avoided by controlling the flow rate of the fluid stream; meanwhile, the clogging problem can also be overcome by using a boiler management system to improve the firing efficiency of the boiler. In addition, cleansing the crust in the furnace should be scheduled, as the presence of crust and ash deposits leads to incomplete flue gas flows, increasing the tube's temperature. Aljohani et al. developed a model using ANSYS to determine the wall temperature which related with deposit thickness in the tube for the prevention of failure [25]. Furthermore, regular inspection of the material properties should be conducted regularly, both on-site and in the laboratory. This inspection is important to predict the remaining lifetime of the material. By carrying out these approaches, inspection, maintenance, and replacement of the old tube can be well-planned. Therefore, the period of boiler tube termination can be predicted and mitigated.
