INSPECTING A BUMP TEST IN THE MAINTENANCE OF A 1200-CC DAIHATSU SIGRA DISC BRAKE

Subekti Subekti¹, Abdul Hamid¹, Basuki Dwi Efendy², Agung Wahyudi Biantoro¹

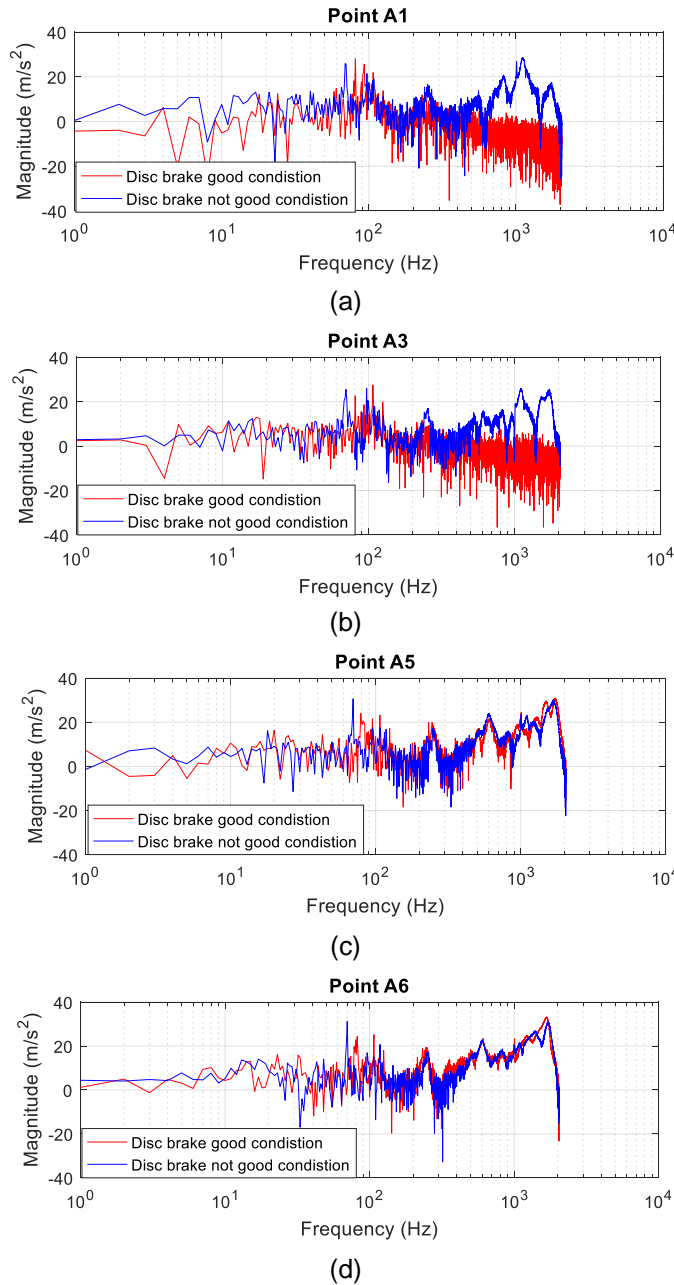
Figure 5. FRF measurement in field A

By using Fast Fourier Transform (FFT), we found out that that at points A10-A10, the global frequencies in a good condition were 40 Hz, 53 Hz, 116 Hz, 125 Hz, 304 Hz, and 504 Hz respectively, while in a damaged condition, the global frequencies were 35 Hz, 48 Hz, 53 Hz, 125 Hz, 503 Hz, and 504 Hz respectively. The analysis of damages on the Disc Brake was conducted by comparing the frequency, which was shown in the forms of FRF as shown in Fig. 5 of the Log-log plot of the same FRF.

Fig. 5(a) showed that in a damaged condition, the initial frequency appeared to be 70 Hz with an amplitude amounting to 19.67 m/s². In good condition, the frequency appeared to be 80 Hz with an amplitude amounting to 25 m/s². In a damaged condition, the initial frequency appeared to be 70 Hz with an amplitude amounting to 18 m/s², while in good condition, the frequency appeared to be around 80 Hz with an amplitude amounting to 13 m/s² as shown in Fig. 5(b).

In Fig. 5(c), there appeared to be no new frequency, but there was a frequency shift in the disc brake in a damaged condition. In addition, it was found out that the frequency in the damaged condition was around 70 Hz with an amplitude amounting to 33 m/s². While the frequency in good condition appeared to be 80 Hz with an amplitude amounting to 15 m/s², this was the same as what

happened at point A6 as shown in Fig. 5(d); moreover, then frequencies in good and damaged conditions occurred at an 80-Hz and 70-Hz frequencies where the amplitudes were 15 m/s² and 37 m/s².

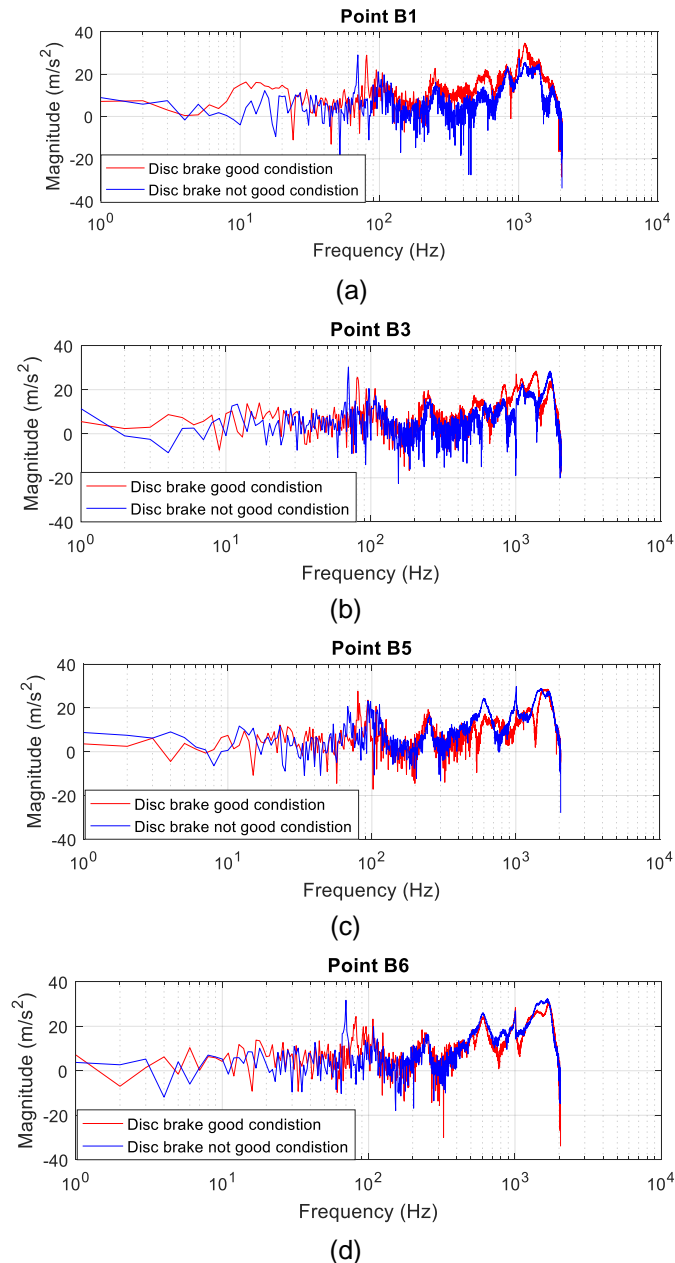
Figure 6. FRF measurement in field B

Fig. 6(a) showed that in a damaged and good conditions, the initial frequencies appeared to be 70 Hz and 80 Hz with the same amplitude amounting to 28 m/s². Fig. 6(b) showed that at point B3, there was a frequency shift like what happened at point B1. We found out that in a

damaged and good condition, there were no changes in the frequency appearance; however, the amplitude in the damaged condition changed the amplitude height amounting to about 32 m/s², while the good condition experienced a decrease in amplitude amounting to 19 m/s².

Fig. 6(c) showed a relation between the frequency and the amplitude. The amplitude in good condition amounted to around 10 m/s², and the amplitude in bad condition amounted to around 24 m/s²; meanwhile, the frequencies in both conditions remained the same. They did not change. Then, there appeared to be no new

frequency, but there was a frequency shift for the disc brake in a damaged condition like what happened at that of point A6 as shown in Fig. 6(d). In Fig. 6(d), the frequencies in good and damaged conditions were 80 Hz and 70 Hz respectively, while the amplitudes were 16 m/s² and 38 m/s² respectively.

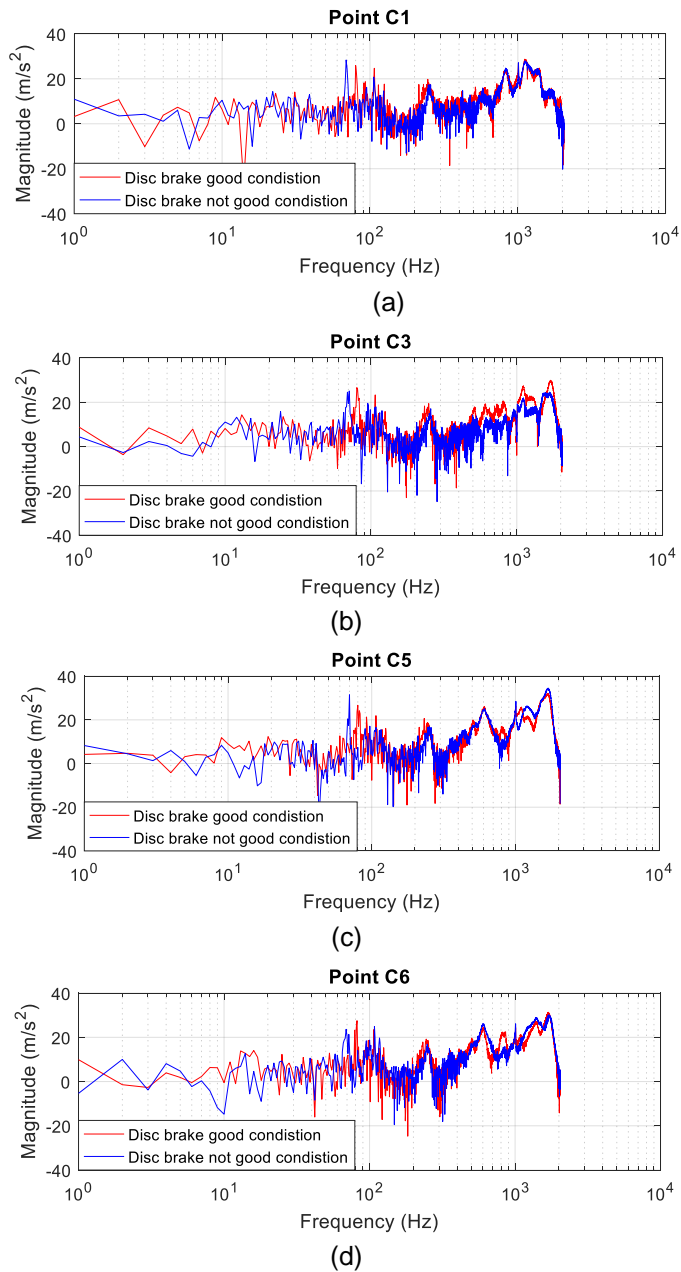
Figure 7. FRF Measurement in field C

condition, the global frequencies were 35 Hz, 48 Hz, 53 Hz, 124 Hz, 128 Hz, 211 Hz, 289 Hz, 413 Hz, 504 Hz, 557 Hz respectively. Fig. 7(b) showed that at point C3, there was a frequency shift like what happened at point C1.

Fig. 7(a) showed that in a damaged condition, the initial frequency appeared to be 70 Hz with an amplitude amounting to 19.67 m/s², while in good condition, the frequency appeared to be 80 Hz with an amplitude amounting to 25 m/s².

In a damaged condition, the initial frequency appeared to be 70 Hz with an amplitude amounting to 18 m/s², while in good condition, the frequency appeared to be around 80 Hz with an amplitude amounting to 13 m/s² as shown in Fig. 7(b).

In Fig. 7(c), there appeared to be no new frequency, but there was a frequency shift for the disc brake in a damaged condition. Moreover, we found out that the frequency in a damaged condition was around 70 Hz with an amplitude amounting to 33 m/s². While the frequency in good condition appeared to be 80 Hz with an amplitude

amounting to 15 m/s² like what happened at point C6 Fig. 7(d) showed us. Furthermore, then frequencies in a good and damaged conditions were 80 Hz and 70 Hz respectively, while the amplitudes were 15 m/s² and 37 m/s² respectively.
