Changes in the form of houses in the earthquake area Cihikeu village, Sarampad, Cigenang, Cianjur

Andjar Widajanti¹*, Juang Esa Ramadhan¹, Raziq Hasan²

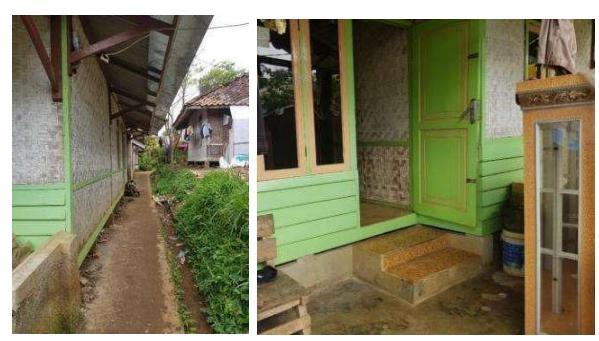
Figure 1. The house is earthquake safe because it uses a stilt structure and woven bamboo walls

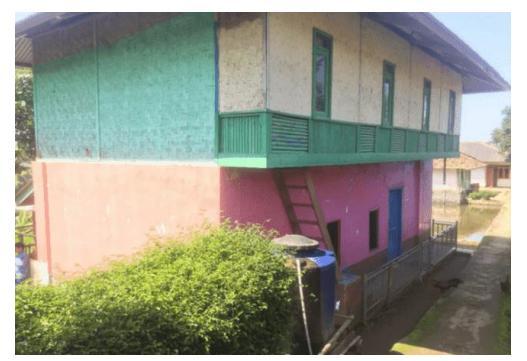
However, this house experienced damage to the ground floor walls in the form of cracks and damage to the roof covering. This indicates that there is not enough attention to the structure of the building.

Figure 9. Side view of a two-story building that suffered moderate damage

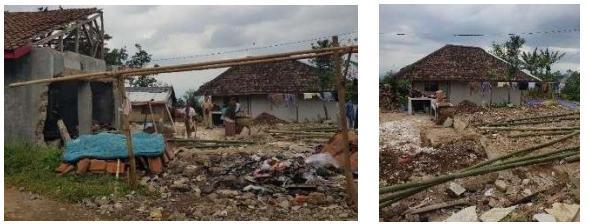
The permanent wall building in Cihikeu Village which completely collapsed

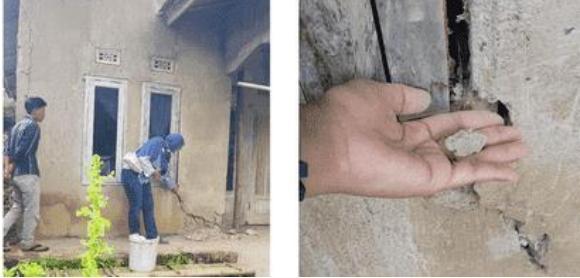
This second type of house has brick walls but without structural reinforcement. This house is equipped with a kitchen, and some have bathrooms. Because this house does not have structural reinforcement, if an earthquake occurs, the building will experience quite serious damage; starting from almost all the walls of the building collapsing, cracks in the walls, and damage to the roof structure to the walls vibrating when held, as shown in Figure 10. The results of this observation are reinforced by research [10] which shows that the main cause of house damage is the weak structural details of the joints between the walls and the roof, the inhesion of the soil roof, and the absence of tie beams on the structural walls.

The house had brick walls without structural reinforcement so when an earthquake occurred, the house suffered damage and cracks on almost all of the walls of the building.

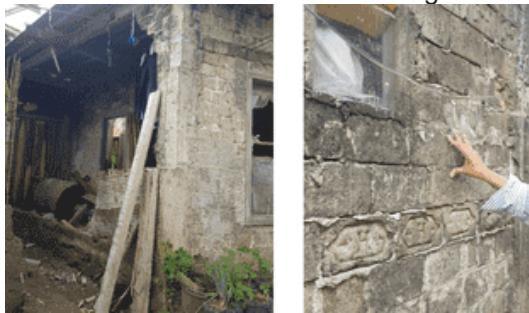
The house, which had brick walls without structural reinforcement, swayed when held Figure 10. The image above depicts a type II one-story house with brick walls without any structural reinforcement so that when an earthquake occurs the building suffers heavy damage.

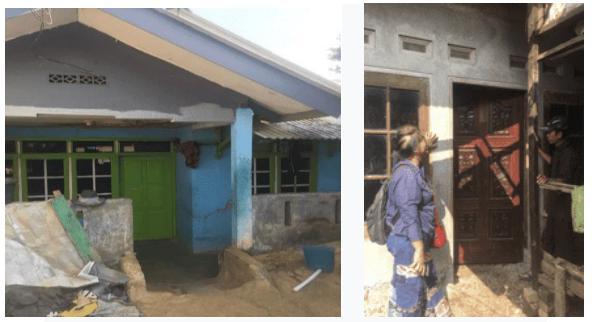
Finally, he changed the building into a concrete structure house. However, unfortunately, when the earthquake occurred, there was a lot of damage on several sides of the building because he did not use beams in the building. Then after the incident, the homeowner finally made repairs and built it according to the proper standards.

Figure 12. The brick house had damage to several sides of the building because blocks were not used in the building
