ADAPTIVE REUSE IN PAGUYUBAN PASUNDAN MANAGEMENT'S OFFICE BUILDING

This study aims to describe changes in the function of space in the Paguyuban Pasundan building related to the old and new functions of the building in the context of adaptive reuse. The city of Bandung has the most cultural heritage buildings with more than 1700 buildings, including class A, B and C. The research method used in this research is descriptive method with qualitative data, with a case study of the Paguyuban Pasundan managements's office Building, which is located on Jl. Sumatra no. 41, Bandung City. Data were collected through observation and literature study from several related studies. The results of this study found that to implement this adaptive reuse, the Paguyuban Pasundan organization only added a few spaces at the back of the building that used to function as a terrace, now, it is a staff room. This organization also seeks to strengthen the historical and cultural values of this building, through the addition of decorative elements in it, and a traditional Sundanese Gamelan music area.

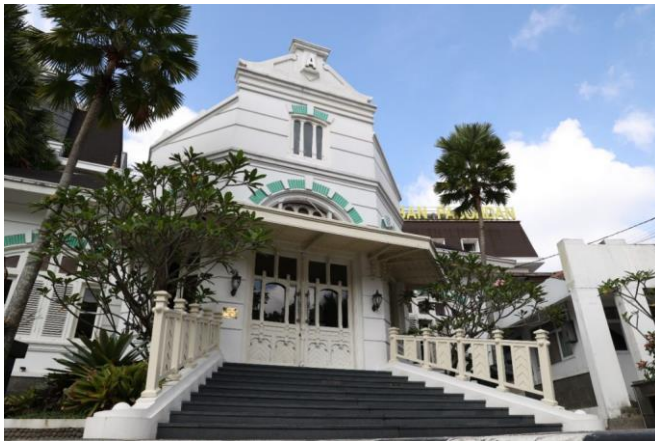
Figure 1. Fasade of Paguyuban Pasundan Building

The Paguyuban Pasundan Building (Fig. 01) was constructed between 1906 and 1915 on a plot of 1630 m². According to the plaque, the structure was initially used as an officer's home, and the architect claimed it had not been filled or empty. Although the identity of the architect who created this structure has not yet been established, it is believed to have been Richard Leonard Arnold Schoemaker, younger brother of renowned Dutch architect Charles Prosper Wolff Schoemaker, according to the official website www.unpas.ac.id. In 1978, the Paguyuban Pasundan group acquired this property from the previous owner who is a doctor.

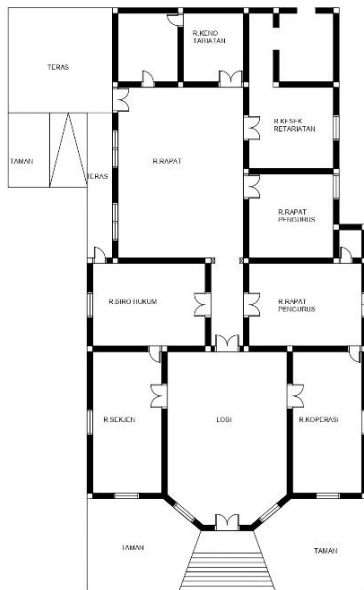
Figure 3. Paguyuban Pasundan Building Plan (2022)

The plans for Paguyuban Pasundan Building (Fig. 03) share similarities with the plans for the colonels' and lieutenants' official residences. However, based on field interviews, it was learned that an original building was demolished right on the left side of the main building (Fig. 04), similar to the plan of the Colonel's official house. It was rebuilt as the Pasundan University Postgraduate building after it was demolished (Fig. 05).

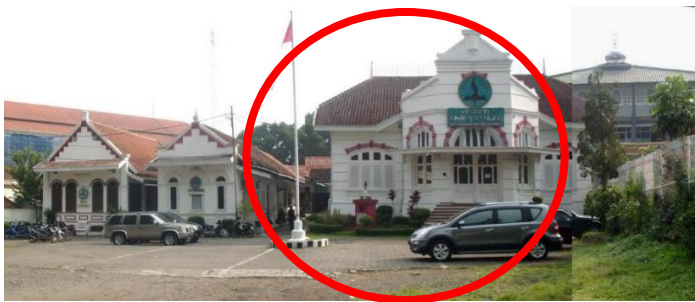
Figure 4. Paguyuban Pasundan Building Complex before demolition of the old building next to the main building
Source : <http://historicalofbuilding.blogspot.com/2010/12/gedung-paguyuban-pasundan.html>

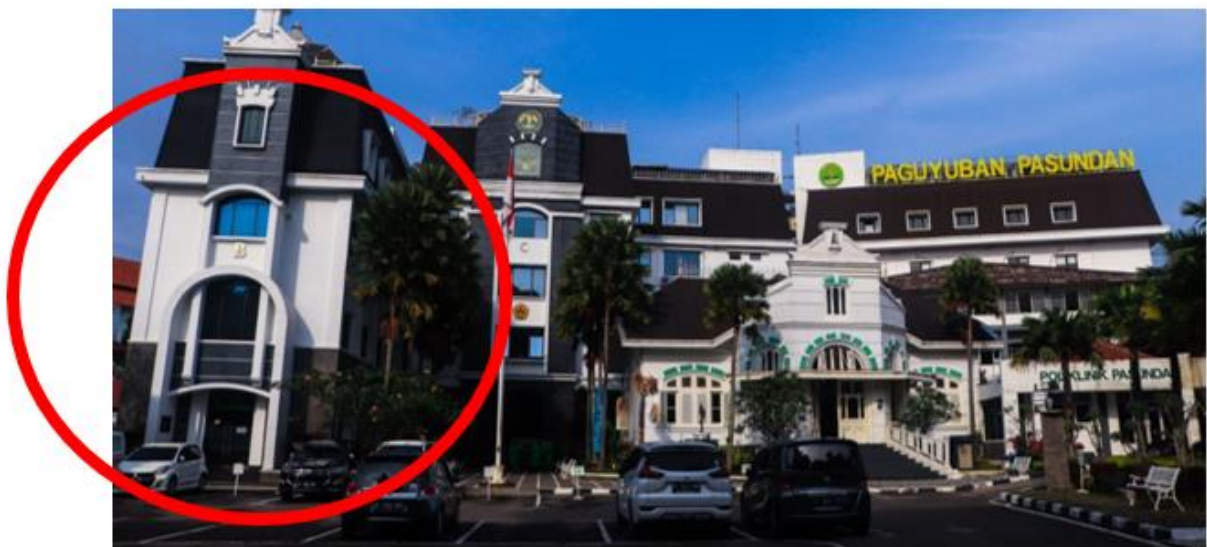
Figure 5. The current Paguyuban Pasundan Building Complex
Source: <https://www.unpas.ac.id/melihara-gedung-paguyuban-pasundan-menghargai-cagar-kultur-dan-asset-sejarah-kota-bandung/>

No	Conservation Ethics	
1	Sustainability	<p>Applying the concept of reuse: The Paguyuban Pasundan management office uses the main building as an office without changing anything. only adding the back due to space requirements. On the floor plan, we can see the back is an addition. In Figures 05 we can see that there are old buildings that were demolished and rebuilt. This is inconsistent with the idea of reuse.</p>
2	Viability	<p>From a financial standpoint, the Paguyuban Pasundan management office can avoid spending money to construct a new office building by utilizing an existing structure. While maintaining environmental sustainability, employing existing structures will prevent the production of embedded carbon during building demolition or reconstruction.</p>
3	Integrity	<p>Maximum Retention Paguyuban Pasundan management office maintains the existing layout. renovation is done to repair the damaged parts only. however, interior elements such as ceilings and walls are given additional decorations.</p> <p>Sensitive Restoration make it like the original. In the renovation of buildings, the Pasundan Association tries to restore existing materials, such as floors, in the process of remodeling floors that have been damaged are dismantled and reassembled, as well as other elements. However, in the cooperative room, there are differences in designs that are not suitable, such as the presence of HPL material and wall treatment so that it does not match the existing conditions.</p> <p>Careful repair: Paguyuban Pasundan office tries to present this building as it was originally, the process of repairing the interior elements is carried out carefully so that it can still be used in better condition</p> <p>Assured Reversibility</p>

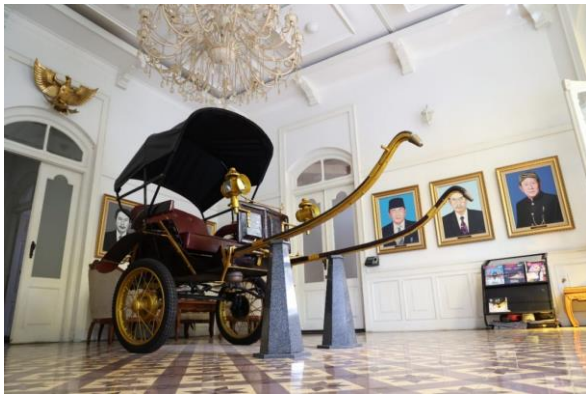
Figure 6. Photo display and horse-drawn carriage in the lobby of the Sunda Paguyuban building

According to field interviews, the Paguyuban Pasundan building underwent several renovations, but did not change its structure. The ceiling and floor have been repaired extensively because they were damaged. To add historical value, the building's lobby features a photo display of Pasundan Paguyuban leaders from the beginning to the present, organized by tenure. Aside from the photo display, there is a horse carriage / wagon in the middle of the lobby room that serves as the room's focal point (figure 06). This horse-drawn carriage display reinforces the room's historical and cultural values.

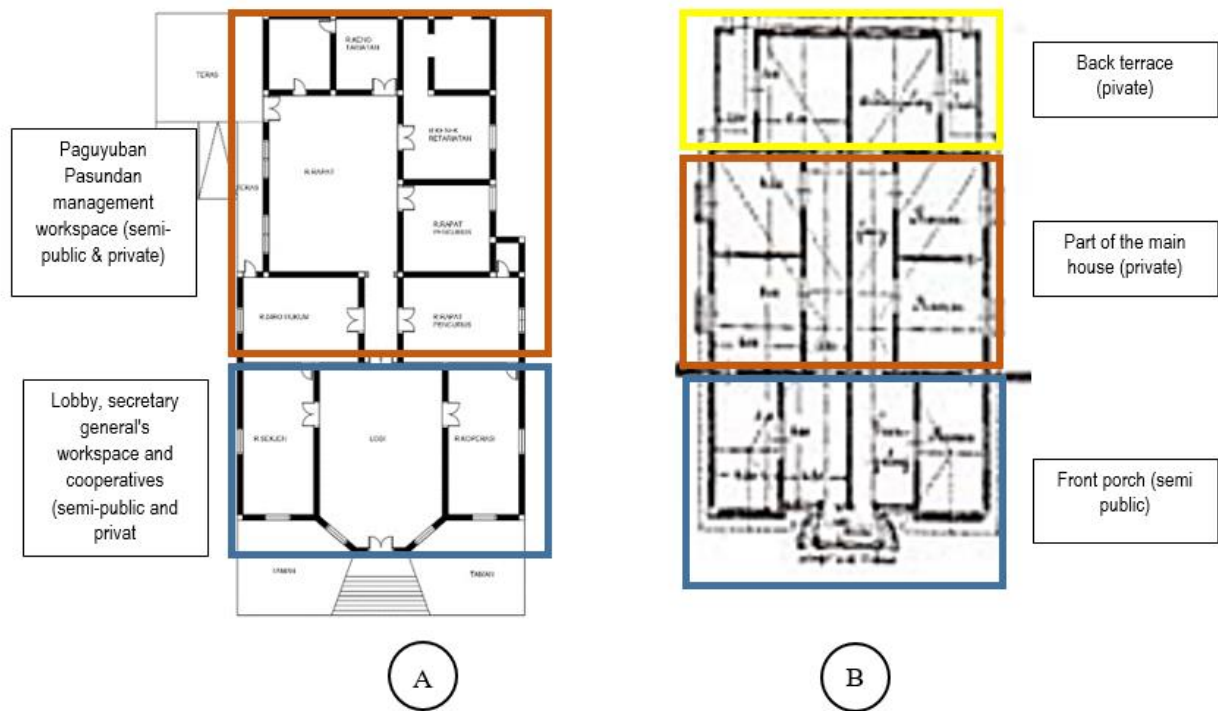
Figure 7. Comparison of the condition of the Paguyuban Pasundan building concerning the colonial residence plan for an officer with the rank of Lieutenant

Paguyuban Pasundan Building Interior Design, because of the change in the building's initial function from residential to office, the Pasundan Paguyuban Building Interior implements adaptive reuse. By implementing adaptive reuse, this building can not only serve as an office, it can also be used to provide historical and cultural insights to visitors. Figure 07 compares the current plan of the Paguyuban Pasundan (A) building to the previous residential building plan with a transitional style (B) according to Handinoto & Hartono (2006). The changes to the zoning and blocking of the Paguyuban Pasundan building are shown in the table below:

The spatial arrangement of the Pasundan Paguyuban building causes the similarity of zones in the past and present even though the function of the building has changed. This is due to the composition of the space that can be read today. As Lawson (2001) says that building can be read as texts. Architecture organizes add structures space of us, and its interiors and the objects enclosing and in habits, its rooms can facilitate or inhibit our activities by the way they use this language.

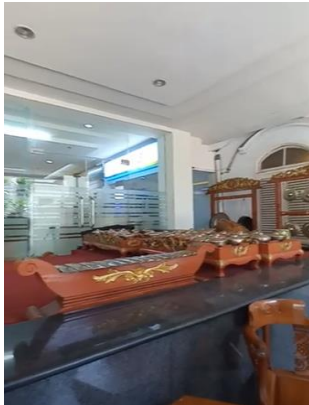
Figure 8. Sundanese traditional music area, Gamelan (2022)

The back of the building, which is now used as a notary room and storage room, was previously an outdoor terrace that was only built after the Pasundan Paguyuban organization occupied it. This means additional buildings from the previous building in the Pasundan Paguyuban building. There is also an addition to the kitchen space, which was previously separated from the building at the back. The strengthening of cultural elements is also carried out to preserve Sundanese cultural identity, as evidenced by the availability of gamelan musical instruments on the building's back terrace (fig 08).

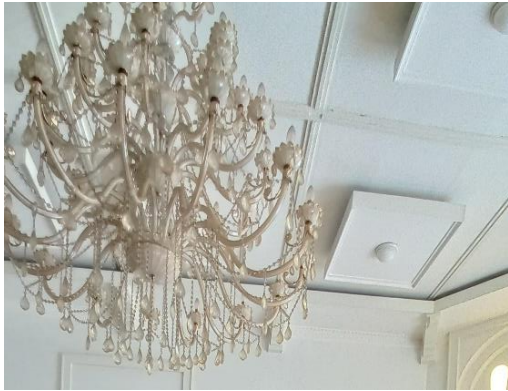
Figure 10. Adding decorative elements to the ceiling in the living room/lobby

The Paguyuban Pasundan Organization's effort to restore this building's historical value includes adding decorative elements, mainly in neo-classical styles, but also art and craft styles, such as in the lobby/guest waiting room. The ceiling is made more decorative by forming boxes

as a drop ceiling and a chandelier in the centre of the room (fig 10). Paguyuban Pasundan's efforts in elevating the historical value of this building are in accordance with the statement of Allison & Peters, (2011) that our ability to create that are not only comfortable, but also inspire us and connect us with our history and our future.

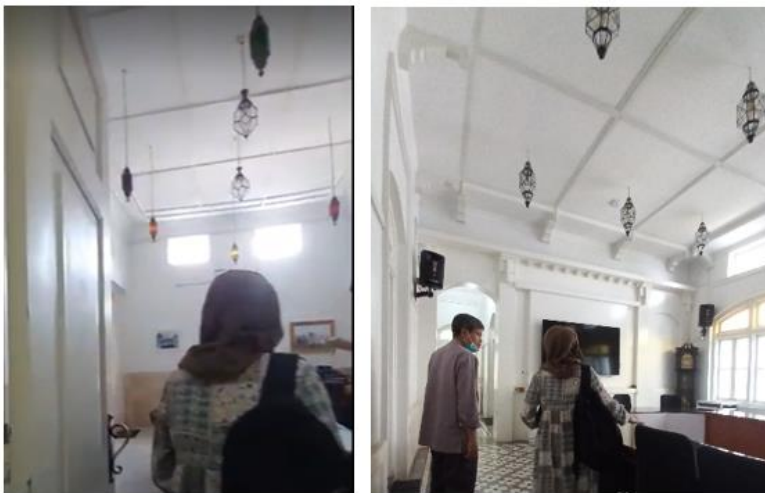
Figure 11. Adding a decorative element to the ceiling in the form of a chandelier in the boardroom and general meeting room(2022)

In addition to the living room/lobby, decorative elements, specifically chandeliers, were added to the board meeting room (Fig. 11 on the left) and the general meeting room (Fig. 11 on the right). The board meeting room (room size 30m²) has eight pendant lights installed, while the general meeting room has 12 pendant lights installed.

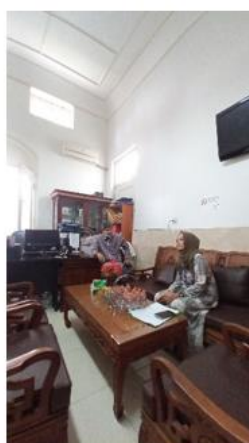
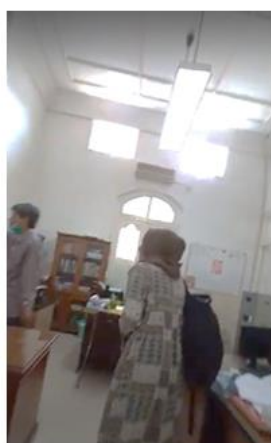
law office division room

Secretariat Room

Figure 12. Pasundan community staff workspace (2022)

According to field observations, the rooms with wall panels and other decorative elements are the living room, board meeting room, and general meeting room. These three rooms are public (lobby), semi-private (r. general meeting), and private (r. management meeting) based on the nature of the space; the rest, staff workspace (figure 12), does not have any additional decorative elements.
