ANALYSIS OF FIRE FIGHTING PUMP PERFORMANCE USING SNI 03-6570-2001 STANDARD ON SELF-CONTAINED HYDRANTS

A. Auf^{1*}, A. W. Biantoro², D. Romahadi^{1,3}, and A. Chaeroni⁴

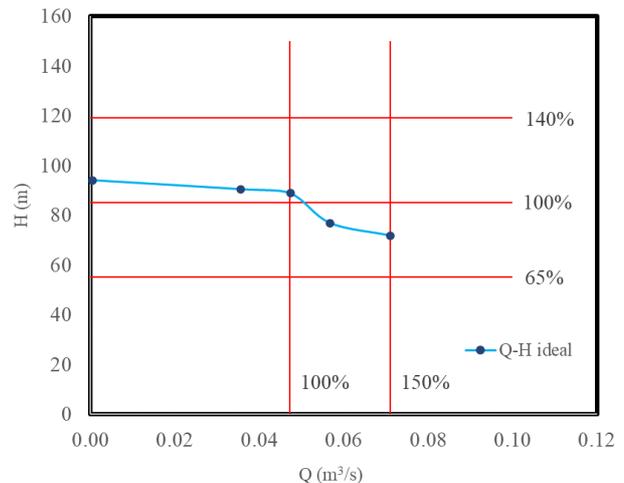
Fig. 5. Performance Graph (Q vs H) of Pump at Ideal Conditions

With the data obtained from standard and factory, there will be different data from the resulting velocity head and total head loss; this will affect the total head of the pump. The total head pump at ideal conditions will be shown in Table 5 and Fig. 5.

From the test results and calculation of pump performance at ideal conditions shown in Fig.6, it can be seen that at ideal conditions, the pump with head 88.83 m should be able to flow a flowrate of 0.0473 m³/s with maximum flowrate 0.0710 m³/s with head of 71.81 m and when shut-off (Q = 0) head at ideal conditions is 94.10 m. At the same time, the fire pump performance in actual conditions has obtained flowrate data at head 86.62 m (rated), which is 0.0189 m³/s, the graph of fire pump performance in actual conditions.

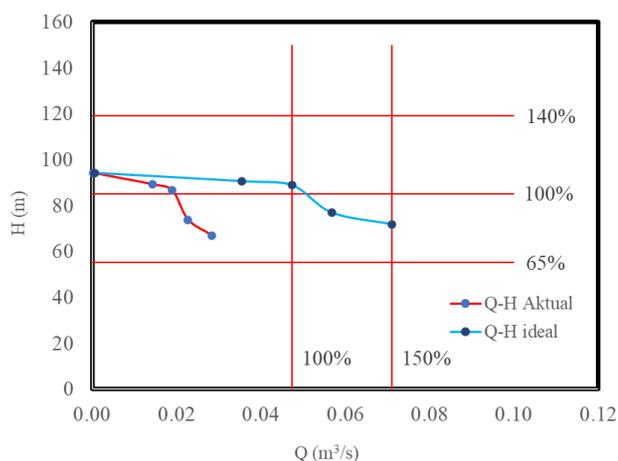
Fig. 6. Performance comparison Q vs H of pump at actual and ideal conditions

The graph in Fig. 5 shows a very significant difference between pump performance in actual conditions and pump performance in ideal conditions; the most significant difference between the two conditions is the flow rate. It is because the author wants to see the difference that occurs in the pump at the same pressure or head; in actual conditions, the fire pump is unable to deliver water more than or equal to 150% of the nominal capacity of the pump at ideal conditions, even fire pumps are unable to drain water according to the nominal capacity of the pump.

Based on the author's analysis, the reason the pump is not able to produce a flowrate by the standard is because of the use of inappropriate pipes; if referring to the SNI 03-6570-2001 standard, pumps with a capacity of 0.0473 m³/s must use a pipe diameter of 0.1524 m, while the pipe installed in the installation with a diameter of 0.1016 m, it will affect the head loss that occurs along the piping installation if the pump is

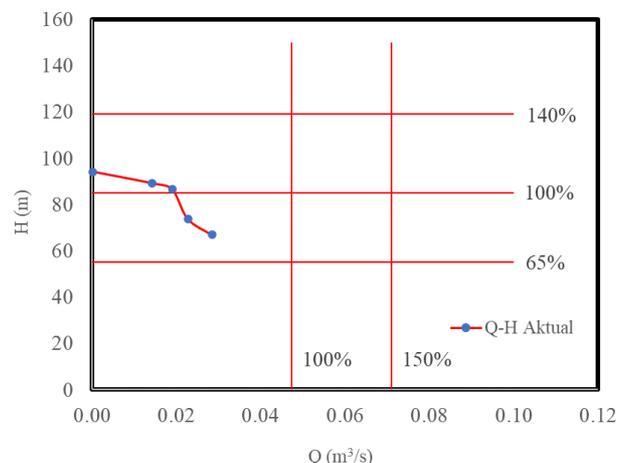
Fig. 7. Performance Graph (Q vs H) of Pumps at Actual Conditions

Based on test data and calculation of pump performance in actual conditions shown in Fig. 7., it can be seen that the fire pump is only able to flow a maximum flow rate of 0.0284 m³/s with a head of 66.94 m. When shut off (Q = 0), the pump has a head of 94.10 m because the pressure used in ideal and actual conditions is the same.

However, if analyzed further, the reason for using a 0.1016 m pipe in a Hydrant is that a hydrant requires adequate pressure and an appropriate flow rate. If you look at the pump performance graph under actual conditions in Fig. 7, it can be seen that the pump can reach the required pressure by the applicable standards; this is indicated by the head still falling within the standard criteria of SNI 03-6570-2001. If the pump is forced to deliver a minimum flowrate of $0.040 \text{ m}^3/\text{s}$ with a pressure of 350 kPa by the SNI 03-1735-2000 standard regarding outdoor hydrants located in residential areas, then with the same calculation stages, the resulting total pump head is 108.52 m at 3000 RPM, the total head is dominated by the head loss that occurs along the pipe. Thus, the pump installed in actual conditions can deliver the minimum flow rate with the required pressure, but due to the high total head, a high speed is also required. More frequent and intense care and maintenance of the pump is required so that the pump is always at its optimum condition. Another reason for using a 0.1016 m pipe is because the pipe is more economical than a 0.1524 m.
