# Analysis of Water Ingress of Composite Sandwich Structure on Cabin Floor of Airbus A330 Aircraft Using ANSYS

**Abstract** - The rapid advancement of aviation technology necessitates rigorous structural evaluations to ensure safety and efficiency. This study focuses on analyzing water ingress in sandwich composite structures used on the cabin floor of the Airbus A330, employing Non-Destructive Testing (NDT) and simulation methods. Using thermography, areas with water ingress were identified, with darker regions indicating trapped moisture within the composite layers. Two cases were analyzed: one with areas requiring repair and another within acceptable damage limits as per the Structure Repair Manual (SRM). The study simulated the effects of pressure and temperature using ANSYS. Results revealed minimal pressure differences, with values ranging between 0 and 0.80 atm. Temperature simulations showed a range of 21°C to 24°C, suggesting potential condensation that could lead to water ingress. Structural simulations evaluated the composite's deformation, elastic strain, and stress distribution. The maximum deformation was 5.1138 mm, with elastic strain peaking at 0.0033772 mm/mm and

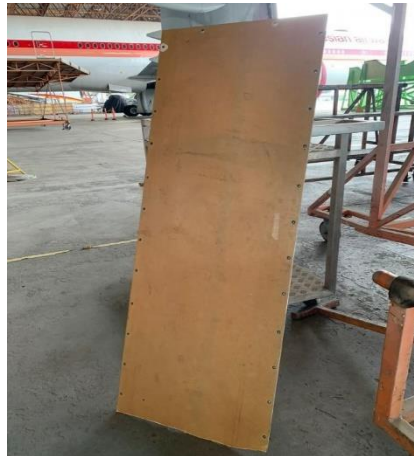
**Figure 2.** Cabin Floor

In this research, the object of this research is the cabin floor structure that uses composite sandwich materials on the Airbus A330. It can be shown at Figure 2.

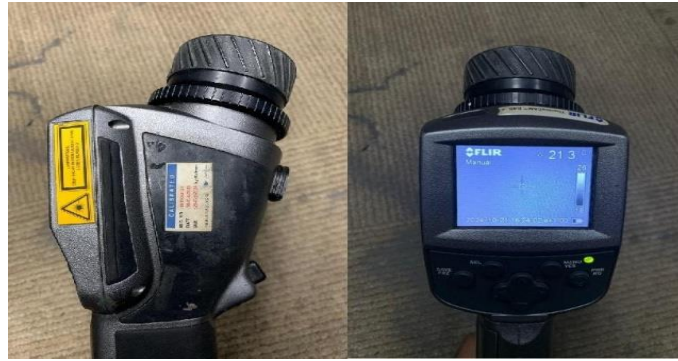
Figure 3. Thermograph

The thermograph method uses infrared camera techniques to detect and measure temperature variations or heat that will be emitted by firing directly at the cabin floor surface to be tested. The detection and measurement results will be converted into an image called a thermogram. The process of setting up the thermograph instrument that will be used during the water ingress identification process can be seen in Figure 3 below:

- Emissivity: 1 %
- Temperature Range: -20° C to 120° C
- Color Palette: Hot White

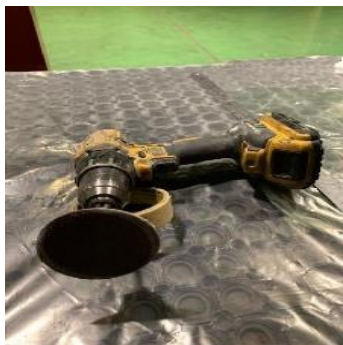
Figure 4. Sanding Machine

The first step that must be done is to open the outer skin in the area indicated by the water ingress with sandpaper or sanding using a sanding machine. This sanding process aims to remove the outermost layer of the water ingress area. This sanding process is done slowly until it meets the honeycomb core. The sanding machine used can be seen in Figure 4 below.

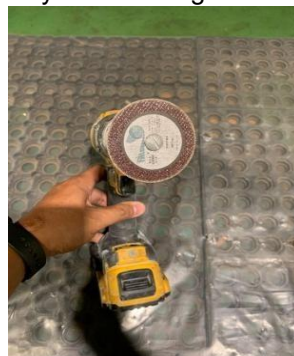
Figure 5. Cutting Wheel

After the sanding process is completed, the second step is the process of cutting the honeycomb core in the area that has been determined by the marking. The honeycomb core cutting process uses a cutting wheel tool so that the cutting results are neat and precise. The cutting wheel tool can be seen in Figure 5 and the results of the honeycomb cutting can be seen in Figure 6.

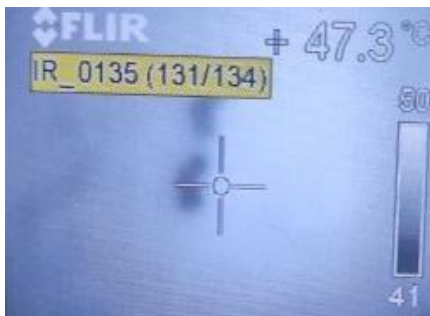
Figure 17. Identification results with Thermograph

The results of the identification of Water Ingress in the composite sandwich structure on the cabin floor with the thermograph method can be seen in Figure 17. The process of identifying water ingress using a cleaning cloth tool.
