Quality circle implementation to reduce defects in cast steel products in the heavy equipment industry

Abstract. *Steel products produced from the metal casting process or commonly called cast steel are still very much needed in the industrial world, as components for production machines, power plants, automotives, heavy equipment and other needs. PT KX is a company that produces cast steel products, the products produced are targeted to be able to meet customer needs both for domestic needs and for export needs abroad. One of the problems currently faced by this company is the high defect ratio in several products currently produced. The defects that occur are porosity, gas holes, sand inclusions, cracks, and misruns. This company's good culture in implementing continuous improvement is well developed in all lines and all members of the organization so that this company continuously makes efforts to reduce defects that occur in products. The aim of this research is to analyze the causes of problems and make improvements to reduce the defect ratio. The method used by Quality Circle (QC) is as a method for making continuous improvements in reducing defects. One of the ways in which

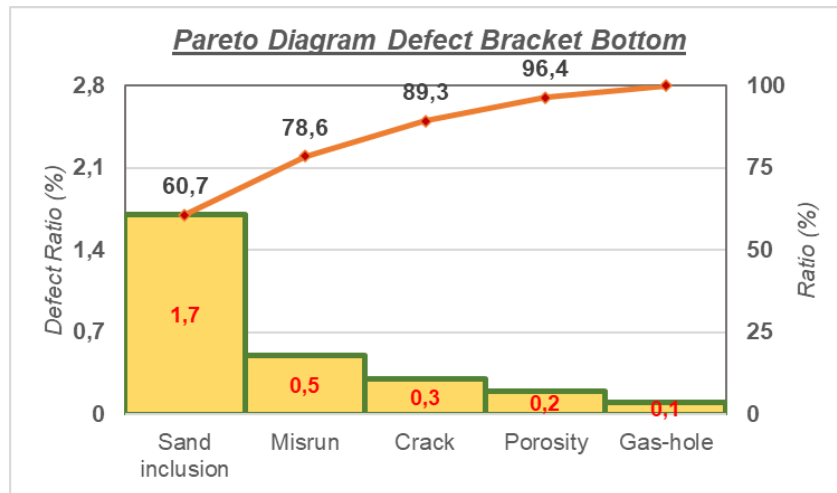
Figure 2. Pareto defect diagram for bracket bottom products

Based on the results of the depiction using a pareto diagram it is visualized that the most dominant defect is sand inclusion with a percentage of 1.7%, misrun 0.5%, crack 0.3%, porosity 0.2% and gashole 0.1%. Henceforth, sand inclusion defects are the focus for handling and repairing in this study.

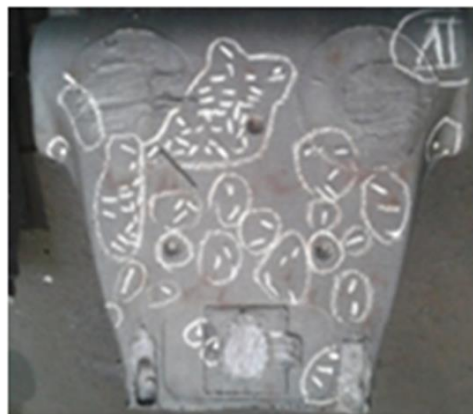
Figure 3. Defect sand inclusion on bracket products

In the above illustration, sand inclusion defects occur under the surface layer of the product, visually these sand inclusion defects are detected as hair cracks on the surface of the product after the crack check process is carried out, but after these small cracks the operator tries to remove them by grinding the surface of the product. the cracks, it turns out that below the surface of the

cracked product there are cavities filled with sand inclusions so it is certain that the defect that actually occurs is sand inclusion (Li et al., 2021). Furthermore, after it was clearly identified that the defect that occurred was sand inclusion, then a search/analysis of the factors that made it possible for the sand to enter the mold cavity/ into the metal fluid was started, causing defects. To find out the possible causes of sand inclusion or sand getting into the metal liquid, a brainstorming was carried out with members of the improvement team, namely leaders, foreman, production supervisors, engineers involved to get some opinions on the causes of defects sand inclusion. From the brainstorming process, there are those who argue that the compressive strength of the molded sand may be low, there are also those who think that the cleanliness of the mold before the assembling process is not given enough attention, the molding sand erodes during the process of pouring molten metal or there are also those who argue that impurity sand (inclusions) is produced by the material. others that are not from molding sand, namely sand that comes from coating material (Kandpal et al., 2021). Opinions regarding the analysis of possible causes of sand inclusion defects are set forth in the improvement tool in the form of a fishbone diagram as shown in Figure 4.

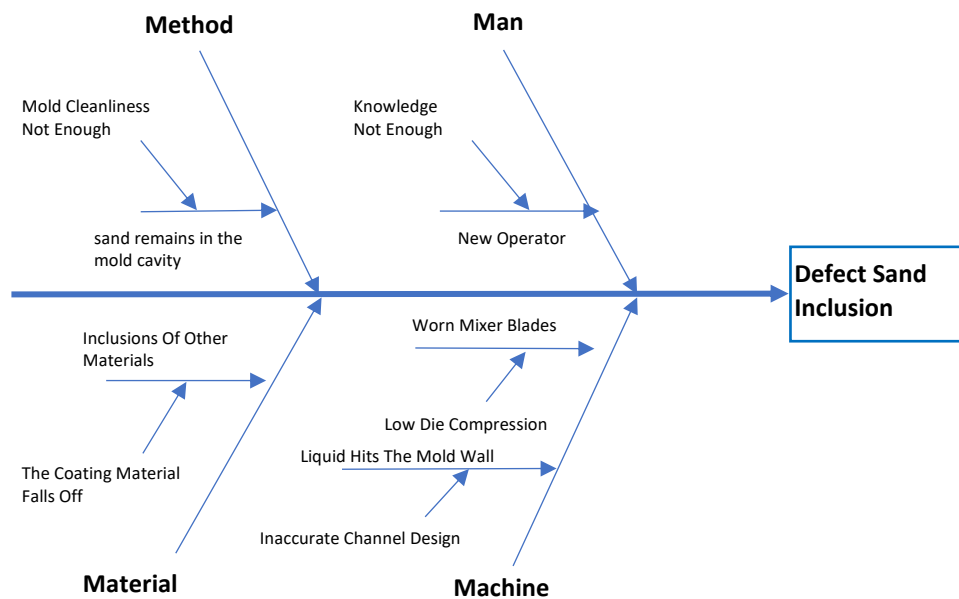
Figure 4. Fishbone diagram of analysis defect sand inclusion

Based on several opinions, one by one each opinion is confirmed for suitability Analysis of possible causes with the facts in the field and in product defects. From the opinions put forward whose confirmation is sufficient with visuals, all of them have been proven that the allegations regarding the possible causes of the problem turned out to be inappropriate/unproven. Next, there is only one more opinion that cannot be confirmed for its suitability, namely the opinion which states that the sand that is an inclusion in the product is sand that comes from the coating material. This opinion means that a proof is needed if the sand that includes the product is an inclusion where most of the content is zircon (Zr) and a small part is silica (Si), this condition causes confirmation of conformity not to be visual, so as a way to carry out the process the proof is with an elemental analysis tool/machine, namely by using an Electron Probe Micro Analyzer (EPMA) machine.

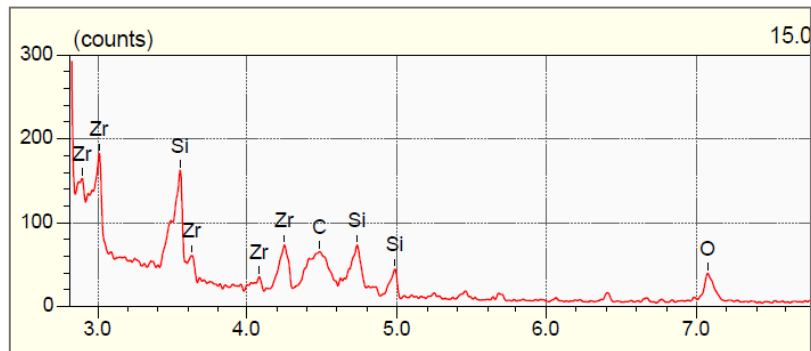
Figure 5. The results of the EPMA test on the defect sand inclusion sample

- The next step is to prepare test samples taken from defects in the product by means of destructive/cutting of the product. The samples that have been prepared are then tested using an EPMA machine with the test results as shown in Figure 5.

From the test results, it was found that the content of inclusions (impurities) in the bottom bracket product was Zircon (Zr) and Silica (Si) elements. Furthermore, the data from this test is very valuable for finding materials containing Zr and Si which cause inclusions in the product. After searching for various materials used in the process of making cast steel, we finally got one type of material that contains the Zr element, namely the material in the mold coating, namely coating material, meaning that one opinion regarding the origin of the inclusions is appropriate/proven. Then further analysis is carried out related to the coating material (Grover et al., 2006). Currently there are two types of coatings used for coating prints, namely coatings with the ISXXXX-8X and ISXXXX-33X types. In this company, the use of coating type ISXXXX-8X is widely used for medium to low products, including being used as a mold coating for bracket bottom products which is currently problematic, while coating type ISXXXX-33X is used for large products. For this incident, testing of the coatings was carried out by visually comparing the absorption to find out how strong and in the absorption capacity of each type of coating into the printing sand (Calderón et al., 2020). The test results and coating comparisons were carried out with the results shown in Figure 6.

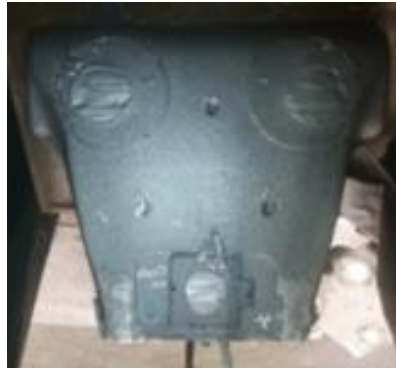
Figure 7. Surface of the bracket product after repair

Looking at the surface condition of the bracket bottom product after the repair, the defects caused by sand inclusion were no longer visible, so a change was immediately determined in the use of coating using the ISXXX-33X type. From the observed results, the defect in the current bracket product has decreased drastically from XX% to zero defect (sand inclusion).

With the condition that the ISXXXX-33X type coating has better performance than the ISXXXX-8X type coating, it is subsequently agreed to propose changing the current coating to ISXXXX-33X type coating. The next step is to conduct an experiment to implement the proposal, the mold is prepared for coating using ISXXXX-33X type coating. The mold is poured using molten steel, the next process is to check the resulting product, observe the results of the product. And the results can be seen in Figure 7.
