## Performance analysis of various types of surface crack detection based on image processing

Regina Lionnie<sup>1</sup>, Rizky Citra Ramadhan<sup>1</sup>, Ahmad Syadidu Rosyadi<sup>1</sup>, Muzammil Jusoh<sup>2</sup>, Mudrik Alaydrus<sup>1</sup>

<sup>1</sup>Department of Electrical Engineering, Faculty of Engineering, Universitas Mercu Buana, Indonesia

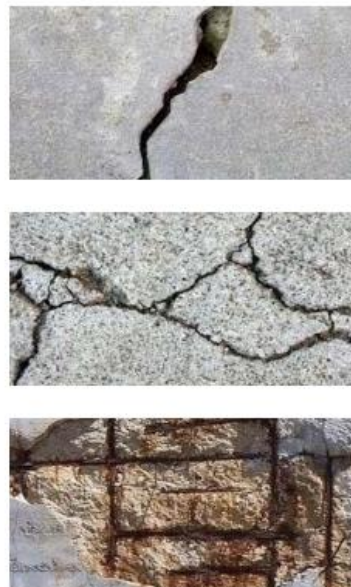
Figure 1. Examples of images with respected types of cracks, from top to bottom, early thermal contraction, plastic shrinkage, and corrosion reinforcement crack images

Crack is the broken on the concrete's surface shown as lines that can be categorized with three parameters: the width, the length, and the pattern [10]. Several types of surface crack such as plastic settlement, plastic shrinkage, early thermal contraction, long-term drying shrinkage, surface crazing, corrosion of reinforcement, alkali-silica reaction, longitudinal and transverse crack. This research analysed three types of cracks: early thermal contraction, plastic shrinkage, and corrosion reinforcement crack images.

- Early Thermal Contraction: Early thermal contraction occurs when there are differences in the temperature caused by the cementing process's heating and cooling effect.
- Plastic Shrinkage: This type of crack usually occurs after one until 8 hours of the concrete placement process when the concrete loses water because of air, temperature, and wind on the concrete surface.

- Corrosion Reinforcement: As the name suggests, this type of crack happened because of the steel bones' corrosion inside the concrete due to the chemical reaction with the environment. The corroded steel bones grow in volume three times the original and create a crack on the concrete.

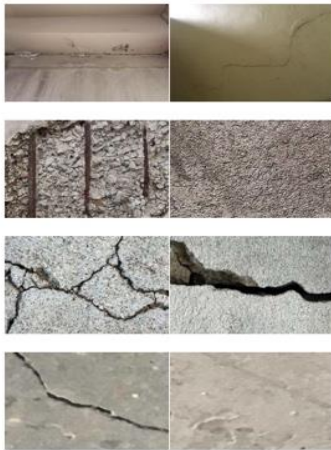
Figure 3. Examples of images in the Database; Database A (top), Database B (middle), and Database C (bottom)

There were three types of Databases used in this research, two surface crack databases (database A and database B) from the authors and one surface crack database (database C) from [17][18]. Database A consists of 14 images with seven surface crack images from the building and seven images of non-crack. Database B consists of 80 images with four types of crack (classes), three types of cracks early thermal contraction, plastic shrinkage, corrosion reinforcement, and one class of non-crack. Each class has 20 images, so the total images for Database B are 80 images: 60 images of crack from 3 types and 20 images of non-crack. The total images from Database C are 4000 images with 2000 images of surface crack and 2000 images of non-crack. Both databases have color (RGB) images, and the size of each image in the databases is different. The size of images in Database A and B is 280x160 pixels. The size of images in Database C is 227x227 pixels. Figure 3 shows the example of each Database's images, upper images from Database A, middle images from Database B, and bottom images from Database C.
