Linear Regression Analysis on predicting the level of damage and changes in Amal Baru Beach Tarakan City Indonesia

Department of Civil Engineering, Faculty of Engineering, Universitas Borneo Tarakan, Indonesia

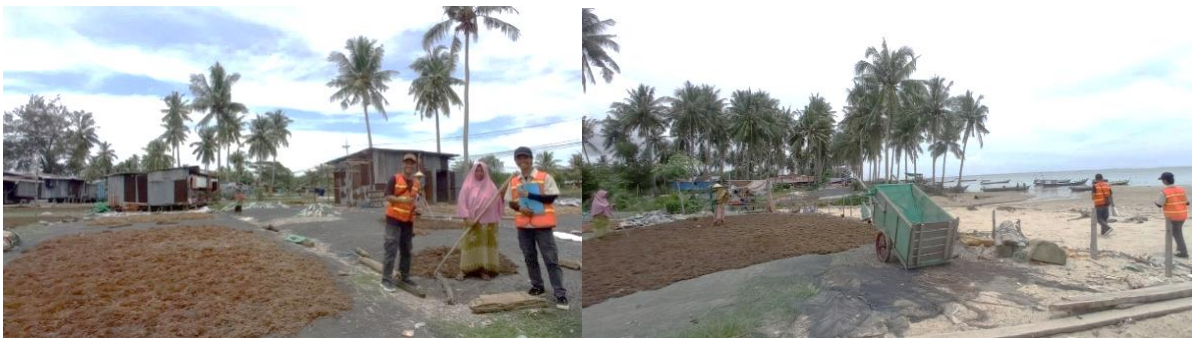
Figure 4. Representation of Land Use as Building and Mixing Seaweed Commodities (Picture Taken During Survey)

The dominance of land use was increasing in the construction and drainage of seaweed commodities, with the form shown in [Figure 4](#). Meanwhile, the calculation result of both the coastal area and the coastal land use as building and land of mixing seaweed commodity were shown in [Table 5](#).

[Figure 4](#) shows the condition of coastal land use for Amal Baru Beach in 2022, dominated by coastal community buildings and the drying of seaweed commodities. Based on the calculation of the land use shown in [Table 5](#), it was found that the area of the coastal area has decreased, which is an average of 0.297 Ha/Year caused by the abrasion phenomenon. In contrast, accretion only occurs on average at 0.0029 Ha/year.

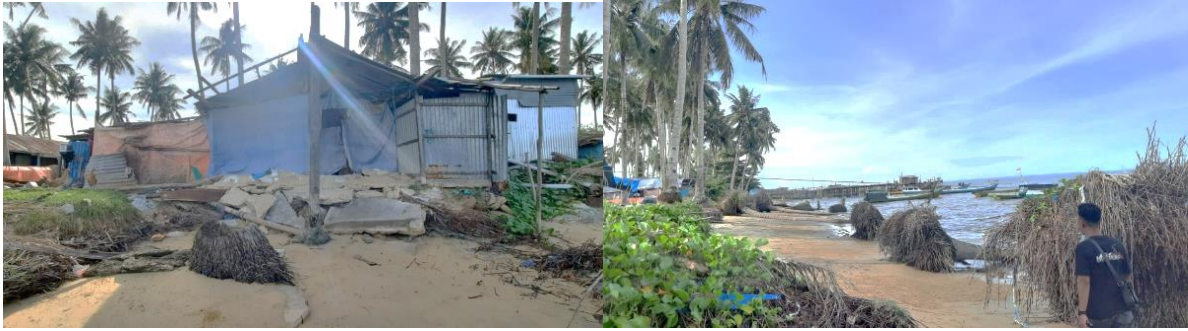
Figure 5. The Condition of Amal Baru Beach in 2022 (Pictures Taken During Survey)

Figure 5 shows the current condition of the coastal area in Amal Baru Beach. Some of the impacts of the abrasion incident are shown from the damage to several coastal community buildings and several fallen trees due to the absence of handling of the abrasion that occurred in the area. Amal Baru Beach, a coastal area, also contributes to cultivating seaweed commodities in North Kalimantan. Therefore, if a coastal guard building does not protect it, a large number of negative impacts will result, for example:
