IMPLEMENTATION OF FREQUENCY RESPONSE FUNCTION ON TAPPER BEARING MAINTENANCE

Ari Susanto, Setyo Qomarudin Yusuf, Abdul Hamid, Haris Wahyudi, Subekti Subekti

Mechanical Engineering Vibration Laboratory, Universitas Mercu Buana,
Jl. Meruya Selatan No. 1, Kembangan, Jakarta, 11650, Indonesia

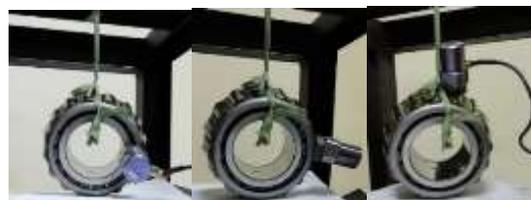
Figure 2. Photo of measurement FRF

The identification of damage that occurs in the taper bearing is made by measuring the FRF. The excitation style is given to the taper bearing in the form of a harmonic signal originating from a cellphone which is then measured using a vibration analyzer. Signal harmonics are given to the bearing surface in a vertical or perpendicular direction to the taper bearing surface. The vibration response measured is carried out on three axes, as shown in Fig. 2, those are the direction of the axis x, y, and z, respectively.

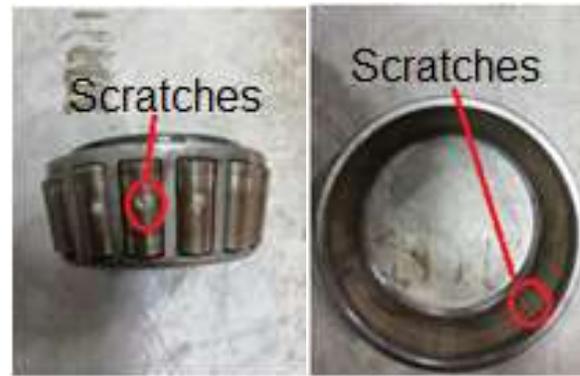
(a) (b)
Figure 17. Taper and House Bearing

After looking at the difference in the vibration signal on the taper bearing, the writer then identified the taper bearing we tested. It can be seen that there was damage (scratch) to the defect that occurred on the ball taper bearing and scratch defects in the taper bearing house, as shown in Fig. 17.
