EFFECT OF CUTTING SPEED IN THE TURNING PROCESS OF AISI 1045 STEEL ON CUTTING FORCE AND BUILT-UP EDGE (BUE) CHARACTERISTICS OF CARBIDE CUTTING TOOL

Abstract -- In the machining of metal cutting, cutting tools are the main things that must be considered. Using improper cutting parameters can cause damage to the cutting tool. The damage is Built-Up Edge (BUE). The situation is undesirable in the metal cutting process because it can interfere with machining, and the surface roughness value of the workpiece becomes higher. This study aimed to determine the effect of cutting speed on BUE that occurred and the cutting strength caused. Five cutting speed variants are used. Observation of the BUE process is done visually, whereas to determine the size of BUE using a digital microscope. If a cutting tool occurs BUE, then the cutting process is stopped, and measurements are made. This study uses variations in cutting speed consisting of cutting speed 141, 142, 148, 157, 163, and 169 m/min, and depth of cut 0.4 mm. From the results of the study were obtained that the biggest feeding force is at cutting speed 141 m/min at 347 N, and the largest cutting force value is 239 N with the dimension o

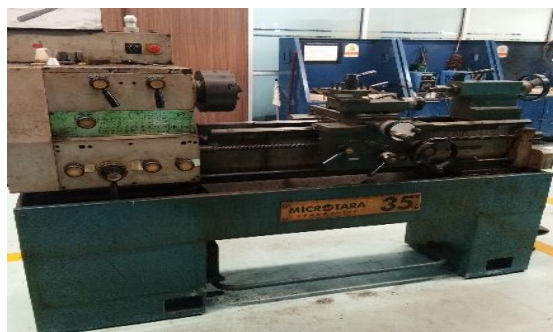
Figure 1. Lathe Machine *Microtara Turnmast35*

Metal cutting is carried out using a Micro Tara Turn Master 35 lathe as shown in Figure 1. The workpiece material is AISI 1045 steel as depicted in Figure 2. The chemical composition of AISI 1045 Steel as listed in Table 1.

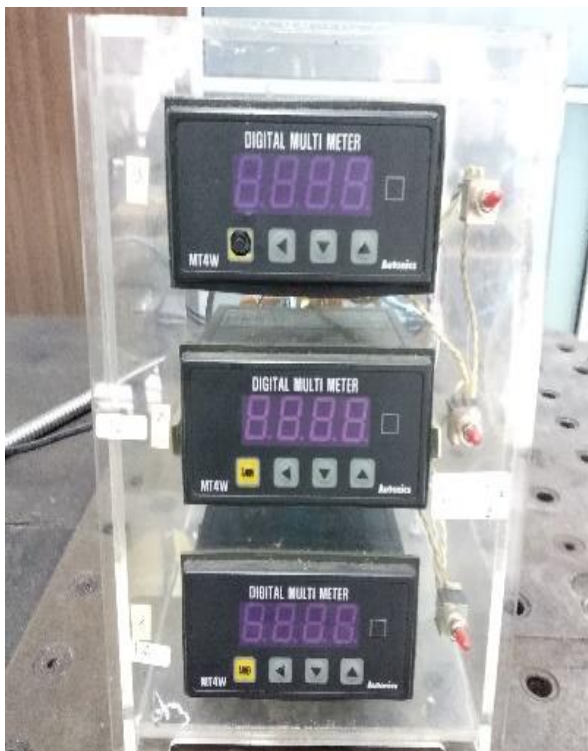
Figure 3. Force Dynamometer

Cutting force measurements are carried out using a dynamometer as shown in Figure 3.

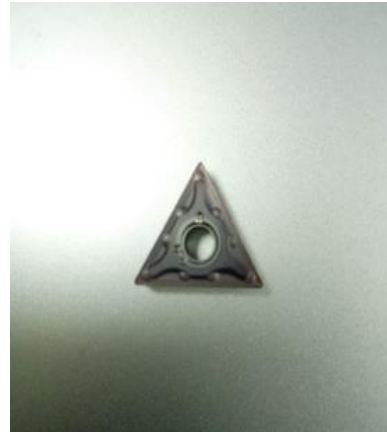
Figure 4. Coated Carbide cutting tool type TNMG 331MA

The cutting tool is coated carbide cutting tool TNMG 331MA type as shown in Figure 4.

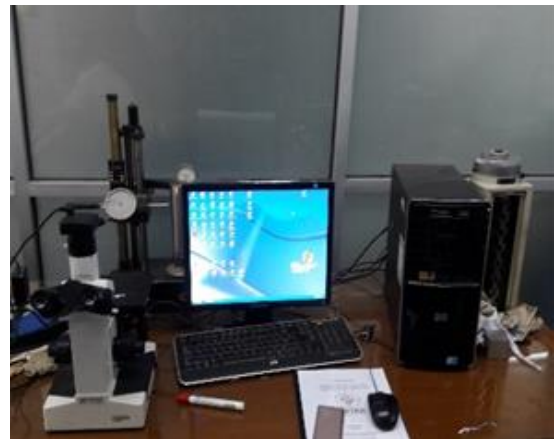
Figure 5. Microscope Jenco Model BC 4-311

BUE observations and measurements that occur in cutting tools using a digital microscope is illustrated in Figure 5.

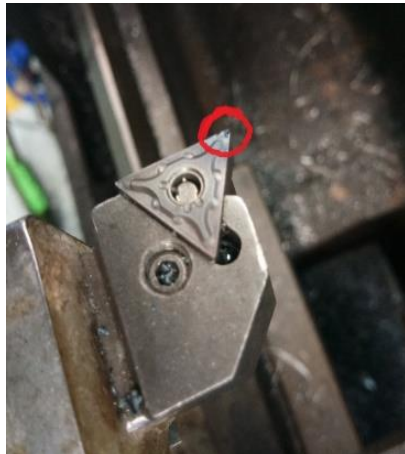
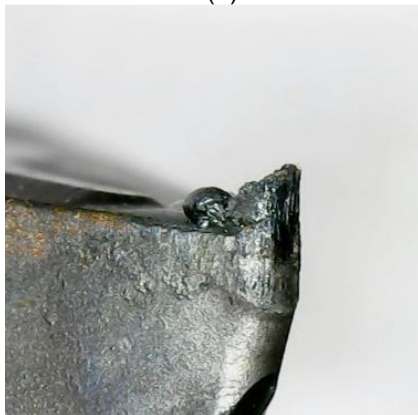
Figure 6. the built-up edge that occurs in the cutting tool

From the experiments conducted, the built-up edge that occurs in the cutting tool is shown in Figure 6.

- (a) Built-up edge attached to the cutting tool
- (b) Built-up edge visible from the microscope

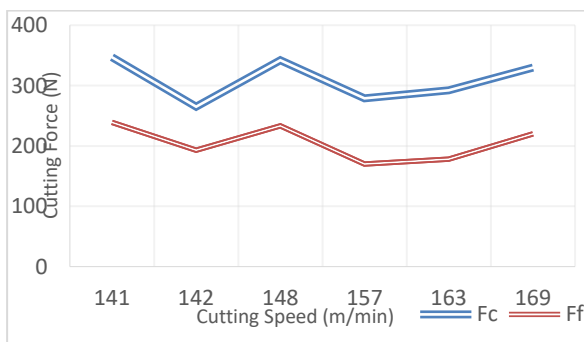
Figure 7. Cutting speed VS Cutting Force

The results of observing and measuring the cutting force using variations in cutting speed are shown in Figure 7.

Based on Figure 7, it can be seen that the value of the cutting force varies and shows a decrease when the cutting speed increases. Figure 6 shows that at a cutting speed of 141 m/min, the cutting force (F_c), and the feeding force (F_f) produced is large. Then with increasing cutting speed, it causes a reduced cutting force. This situation occurs if the cutting speed increases based on the speed of feeding the workpiece, which is getting bigger, causing the chip to stick to some of the corners of the cutting tool. This condition is caused by high cutting temperatures, which affect the formation of BUE at the tool angle, and an increase in cutting force also causes cutting power to increase.

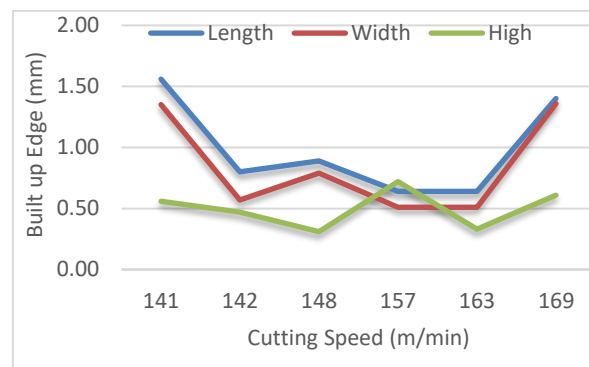
Figure 8. Effect of Cutting Speed on Built-Edge Size

From observations made during the machining process, BUE can occur at any cutting speed, but the BUE shape that occurs includes varying lengths, widths, and thicknesses, as presented in Figure 8.

Based on Figure 8, it can be seen that the BUE that occurs does not depend on the cutting speed (V_c). But due to the release of the cutting temperature that does not occur properly. So, some of the heat still occurs on the chip and eventually spreads and increases to the cutting tool angle. BUE size is different at each cutting speed. In Figure 8 it can be seen that the cutting speed of 141 m/min in experiment 1 produces a size larger than BUE than the cutting speed of 142 m/min in experiment 2 which results in a size smaller than BUE, this occurs because when the cutting speed increases, there is an increase in temperature and the tip of the chip attached to the cutting tool is peeled off from the cutting tool, this causes the BUE dimension that occurs on the cutting tool to be smaller compared to the previous cutting speed.

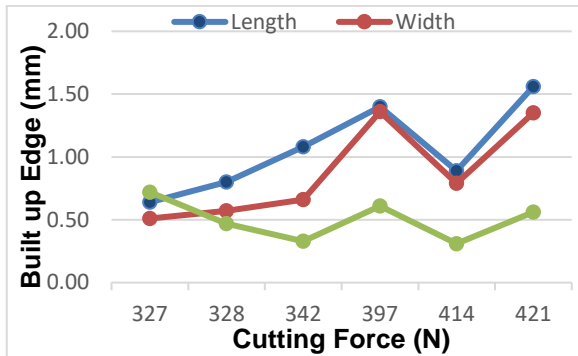
Figure 9. Cutting force on the Built-Up Edge dimensions

Based on Figure 9, the effect of increasing cutting speed affects the cutting force. With the occurrence of BUE on the cutting tool, the cutting force that occurs in the cutting process is greater because the angle of cutting tool no longer performs its function for metal cutting. Still, the BUE is rubbing, so it requires a force greater to do a metal cutting process. Other effects arising from the presence of this BUE the surface condition of the workpiece becomes rougher, and cracks occur on the cutting tool faster because of BUE shifts and peels off the surface of the cutting tool attached to the BUE. Based on Figure 8, it can be seen that the increase in the length and width of BUE is more significant than the height of BUE. The situation is especially true for the cutting force of 397 N.

The size of the built-up edge is also influenced by increased cutting force. The built-up edge that occurs in the cutting tool affects the cutting of uneven workpieces. From these results, it can also form large chips due to changes in the force produced and high temperature when rubbing between the cutting tool and the workpiece, so that the surface conditions of the workpiece produced are high roughness.
