Experimental study of rainfall intensity on silty sand slope

Abstract

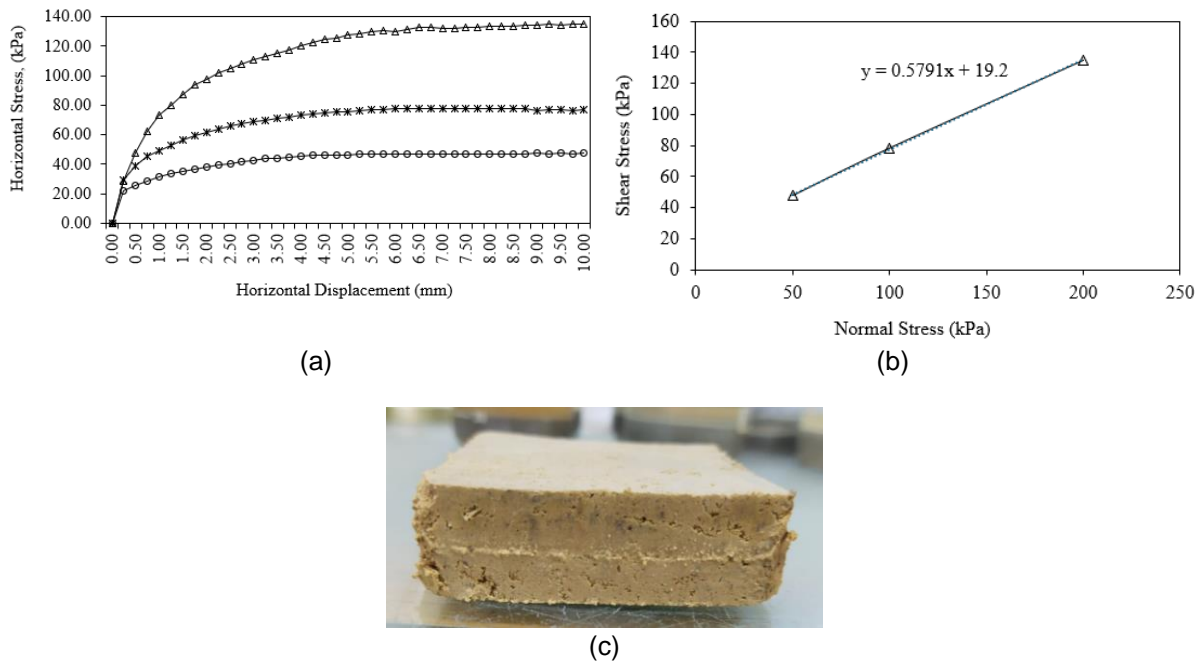
Figure 6. Drained shear strength test (a) Stress-displacement graph (b) shear strength of soil (c) failed sample

The drained shear box test was conducted at three different normal stresses, 50, 100, and 200 kPa for samples A, B, and C, to determine the Mohr-Coulomb strength parameter. The strain rate applied is 0.25 mm/min. The effective cohesion, c' , and angle of internal friction, ϕ' , were 19 kN/m² and 30°, determined from Figure 6.
