Estimated Life Loss of a 3-Phase Induction Motor Based on Insulation Resistance Test at PT. Delta Jaya Mas

Abstract— Induction motors play a crucial role in the production process at PT. Delta Java Mas, making insulation resistance (IR) testing essential for maintaining operational reliability. IR is a key parameter that measures the ability of motor winding insulation to withstand electrical current, influenced by factors such as humidity, environmental temperature, and operating time. This study evaluates insulation resistance degradation in a 75 kW three-phase induction motor following IEEE Std 43-2000 guidelines. Testing was conducted while the motor was deenergized to prevent component damage. Polarization index data was recorded over a 10-minute interval. Initial testing on a damaged motor revealed insulation resistance values between 515 M Ω and 602 M Ω , with one phase measuring 0 M Ω , indicating a short circuit. After repairs, insulation resistance improved to 2000 M Ω . However, after three months of operation, resistance decreased at an average rate of 11.6 M Ω per month, with a polarization index of 3.5 M Ω . The findings suggest that, under consistent degradation rat

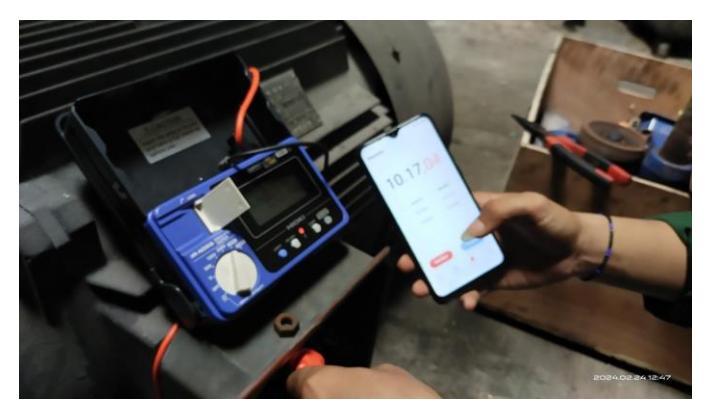
Figure 1. Insulation testing with a megohmmeter

The Polarization Index (PI) calculation is used to assess insulation degradation in a three-phase induction motor by measuring insulation resistance over a period of 1 to 10 minutes. The test was conducted using a megohmmeter, as shown in Figure 1.

Based on Equation (1) for testing the Polarization Index (PI), the results are presented in Table 13 and Table 14. From the test results, it can be observed that the PI degradation value before repairs was very poor according to IEEE Standard No. 43, as explained in Table 13 and Table 14. However, after repairs to the induction motor winding, the PI value improved significantly.
