Estimated Life Loss of a 3-Phase Induction Motor Based on Insulation Resistance Test at PT. Delta Jaya Mas

Reza Sarwo Widagdo^{1*}, Puji Slamet¹, Aris Heri Andriawan¹, Mochamad Rama Firmansyah¹

Abstrak— At the company PT. Delta Jaya Mas induction motors are very necessary to run machines in the production process. An induction motor consists of a rotor and stator with insulation resistance. Insulation Resistance (IR) is a measure of the ability of the insulation in the winding to withstand current. Insulation resistance testing is needed to determine the condition of the insulation which is influenced by humidity, environmental temperature and operating time. This test procedure is regulated in the IEEE Std 43-2000 standard. The use of an appropriate insulation tester and routine testing is important to maintain the insulation resistance value and prevent accidents and damage to 3-phase induction motors. Testing is carried out when the motor is turned off to avoid component damage. Polarization index data is taken by testing the insulation resistance for 1 to 10 minutes. The test was carried out on the insulation resistance of a three-phase induction motor with a power of 75 kW w

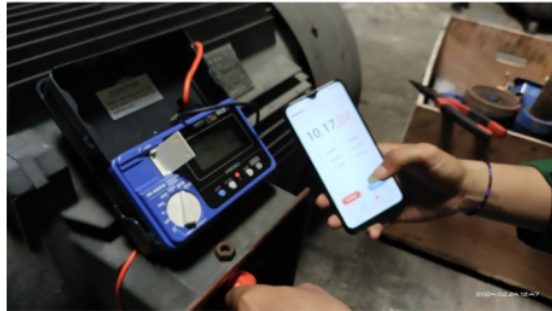
The Polarization Index (PI) calculation is used to determine the insulation degradation value in a 3-phase induction motor which is measured over 1 to 10 minutes. The test was carried out using a megohmmeter as shown in Figure 1.

Figure 1. Insulation testing with a megohmmeter

Based on equation (1) for testing the Polarization Index (PI) which is written in Table 13 and Table 14. From the results of the tests that have been carried out, it can be seen that the PI degradation value before repairs has a very bad value according to IEEE standard No. 43 which is explained in Table 13 and Table 14 with better conditions after repairs to the induction motor winding.
