# ROOT CAUSE ANALYSIS OF COLLAPSEABLE ALUMINIUM TUBE FAILURE ON LJ-60 TYPE IMPACT EXTRUSION PRESS MACHINE USING THE FAULT TREE ANALYSIS (FTA) METHOD

**Abstract**--The impact extrusion press machine is a machine that supports the manufacture of folded aluminium tubes. There are supporting components, namely dies and punches. These dies and punches have a lifespan and valuable life. Checking and replacing are necessary to be done regularly, as they have a significant impact on the quality of the tube. This research aims to analyze product failure resulting from the impact of extrusion press machines on the interaction between parts and dies and punches. Folding aluminium tubes are often used for glues, ointments, cosmetics, and other purposes. During the production process, leaks and defects were found in the tube. Tube quality that does not meet standards will cause various problems. The influence of settings on dies, punches, and skewed stamps results in the shape of the tube becoming ugly and unusable. The impact of the extrusion press machine and operator, apart from the dies and punch, also has a big influence on the results of collapsible aluminium tubes. Apart from these fact

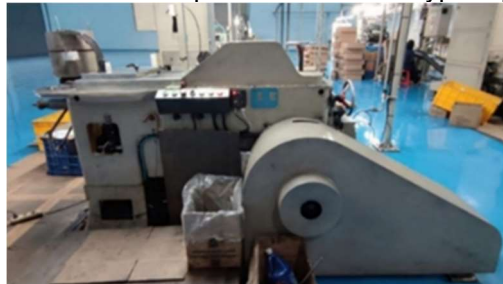
**Figure 1.** LJ-60 impact extrusion press machine (3D)

Making collapsible aluminum tubes requires several machines. One machine that plays an important role is the impact extrusion press machine. The impact extrusion press machine that we use is the LJ-60 type. The LJ-60 type impact extrusion press machine is capable of producing extrusions with diameters ranging from  $\varnothing 11.4$  mm to  $\varnothing 18.9$  mm. Below is a picture of the LJ-60 type impact extrusion press machine.

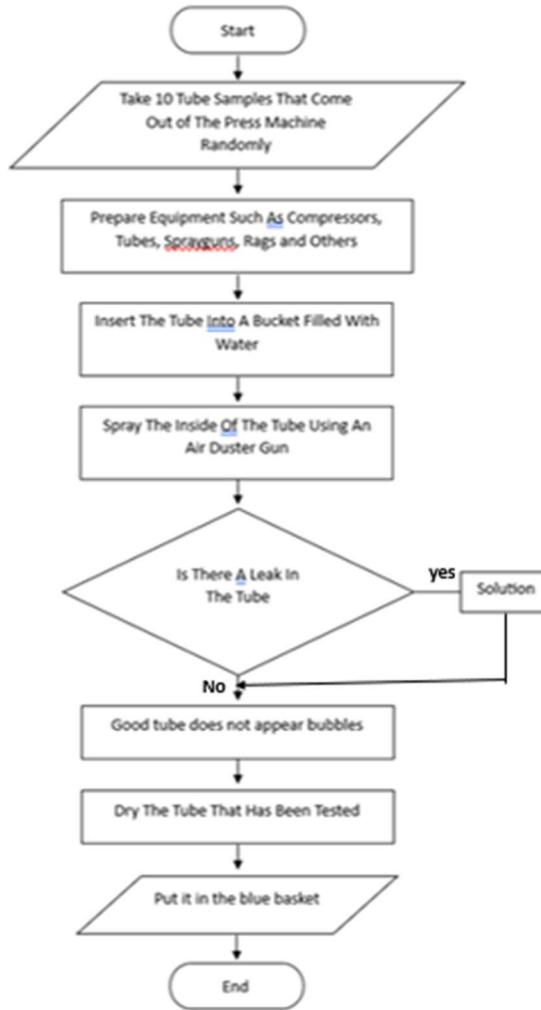
**Figure 4.** Tube Leak Testing Flowchart

Next, in Figure 3, is a flow diagram of tube leak testing

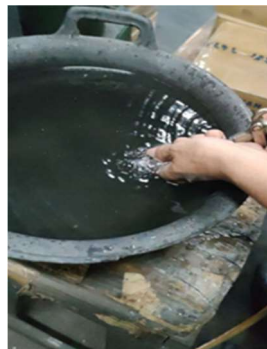
**Figure 5.** Tube Leak Testing

Leak testing on collapsible aluminum tubes is conducted to ensure the tubes remain hygienic, maintain optimal tube quality and glue adhesion, and prevent contamination and leaks that can be detrimental to both consumers and the company. The following is a picture of leak testing on the tube.

There are several indicators that there is a leak in the aluminum collapsible tube. One of them is that bubbles or foam appear in the water. This process uses a pressure of 6 bar obtained from the compressor. There are seven steps for leak testing.

- Take 10 tube samples from the press machine at random.
- Cut the end of the tube so it is neater and doesn't stick out.
- After that, we spray it using a spray gun from inside, and put it in a bucket filled with water
- If a leak occurs, bubbles and water splashes will appear.
- A good tube will not leak.
- Then we separate the leaking tube and put it in a cardboard box.

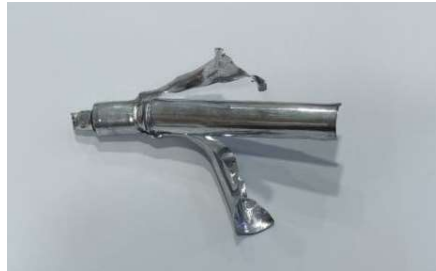
**Figure 6.** Extreme Damage to the tube

Failure can occur in both impact extrusion press machines and in dies and punches, as well as in vibratory feeder controllers and aluminum collapsible tubes. There are several causes of tube failure, one of which is due to the punch being off-center. This results in the aluminum slug not being able to be pressed properly, resulting in a defective tube. Failures can be overcome using the fault tree analysis method. Fault tree analysis (FTA) is a top-down approach to analyzing failures, starting with a potential event or accident called a top event and determining how the event could [3]. In Figure 6, the damaged tube is illustrated.

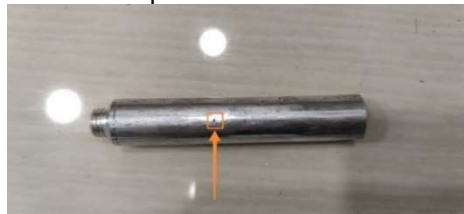
**Figure 7.** Leak in the tube

In Figure 7, there is a small leak in the collapsible aluminum tube

To reduce and avoid failures, changes and modifications to the system must be made, one of which is the installation of sensors.

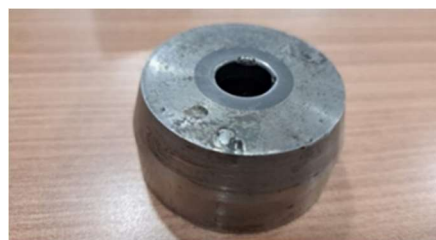
**Figure 8.** Dies Damage

Dies are molds found in impact extrusion press machines. Damage is often found on the dies. This part is made of tungsten, which is generally very hard. One of the damages to the dies occurred because the punch with the aluminum slug was not centered and tilted when extruded. As a result, the surface of the dies becomes lumpy, deformed, and uneven. In Figure 8. This is an example of Damage that occurred to the dies

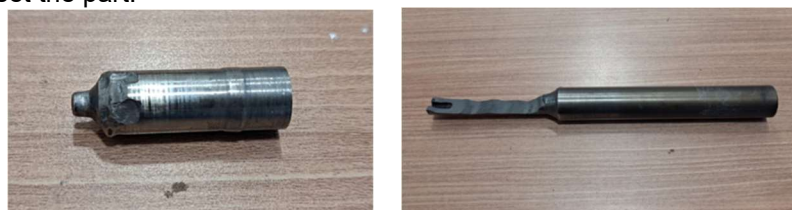
(a) (b)  
Figure 9. Figure (a) Stamp Damage, (b) Punch Damage

Stamps play an important role in forming a tube. When doing a replacement, the punch or stamp operator must reset the part.

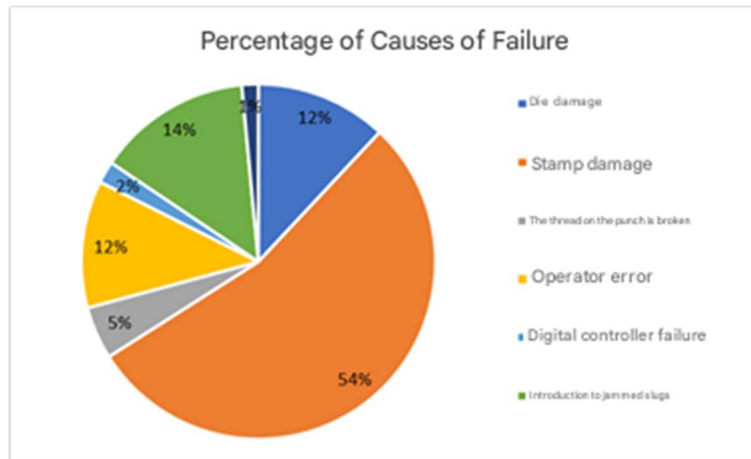
**Figure 14.** Circle diagram of causes of Damage

Number	Basic Events	Probability
1	Dies Damage	12%
2	Stamp Damage	54%
3	The thread is broken	4.8%
4	Operator faults	11.6%
5	Digital controller failure	2%
6	The feeder gets stuck	14.1%
7	Vibratory feeder not working	1.5%

The primary failure is caused by stamp damage, accounting for 54%. Meanwhile, the smallest failure probability value is caused by the feeder not running properly, which is 1.5%. For more details, see the image below.

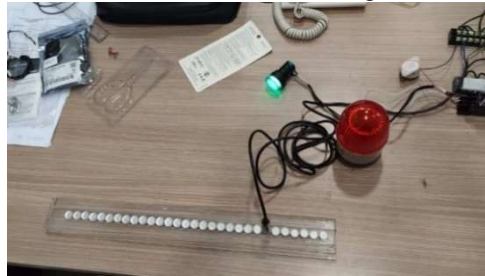
**Figure 14.** Planning system detection of aluminium slugs  
After that, we run the system as shown in Figure 15.

The aim of making this prototype is to test the accuracy and ability of the proximity sensor to detect aluminium slugs. The system is then assembled as shown in Figure 14.

Testing of the prototype has been carried out. The test results indicate that this detection system functions properly, with the green indicator light in standby, the buzzer sounding loudly, and the flasher flashing normally. This type of proximity sensor is also very sensitive and is suitable for application on LJ-60 type impact extrusion press machines.
